# **SERIES**

## **SEISMIC ENGINEERING RESEARCH INFRASTRUCTURES FOR EUROPEAN SYNERGIES**

### **SEISMIC PERFORMANCE OF MULTI-STOREY TIMBER BUILDINGS**

#### **Rusticasa building**

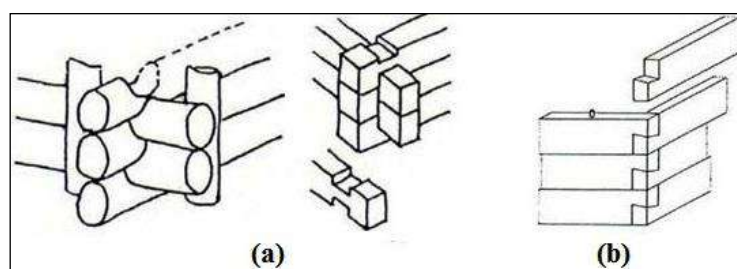
**Figure 1.1: Corner log notching techniques in: (a) Central and Eastern Europe; (b) Western Europe [1]**

Timber has been used as a construction material since times immemorial. In ancient times, timber logs were either used to build entire houses or as timber frame elements in roofs. Log constructions consist of walls made by stacking horizontal logs one above the other. The logs are shaped such that they form a perfect fit with the log below. This is important as it makes the system air-tight, increases moisture resistance and improves thermal and acoustic properties. The contact area between the logs and the compression strength perpendicular to the grain determine the resistance to vertical loads and the horizontal loads are supported by cross walls, with the friction between the joints playing a pivotal role. In areas of Central and Eastern Europe with abundant forest trees, log houses date back to the Stone Age. They were constructed by stacking logs horizontally with notches provided at corner intersections. The log house construction technique followed in Western Europe was more refined as the logs were trimmed and the cross wall intersections were facilitated by dovetail notches [1]. Figure 1 depicts some of the techniques of notching for cross wall intersections.

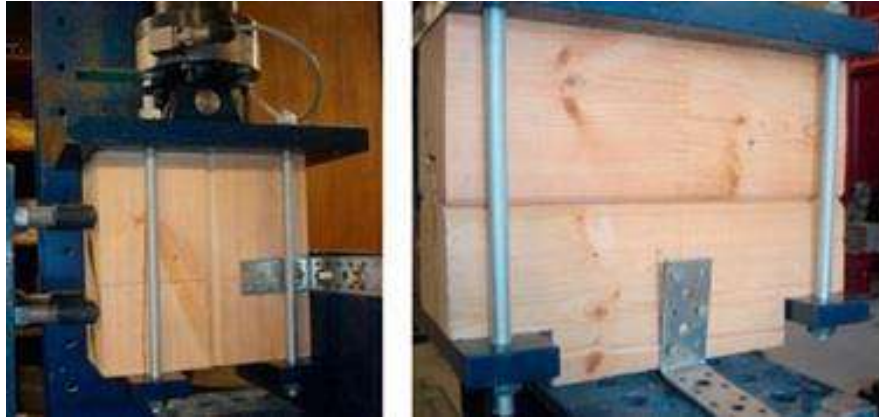
**Figure 1.2: Layout of the shear test (left) and tension test (right) performed on connection of the base log and foundation [4]**

During the first phase of the project, the behaviour of connections between the sill logs and the foundation was assessed through a series of shear and tension tests under cyclic loading. Shear tests revealed that the connections have a good capacity to dissipate energy. From the tension tests, the deformation required to determine the maximum resistance of the connection was determined. In Figure 1.2, the shear and tension test set-ups are seen.

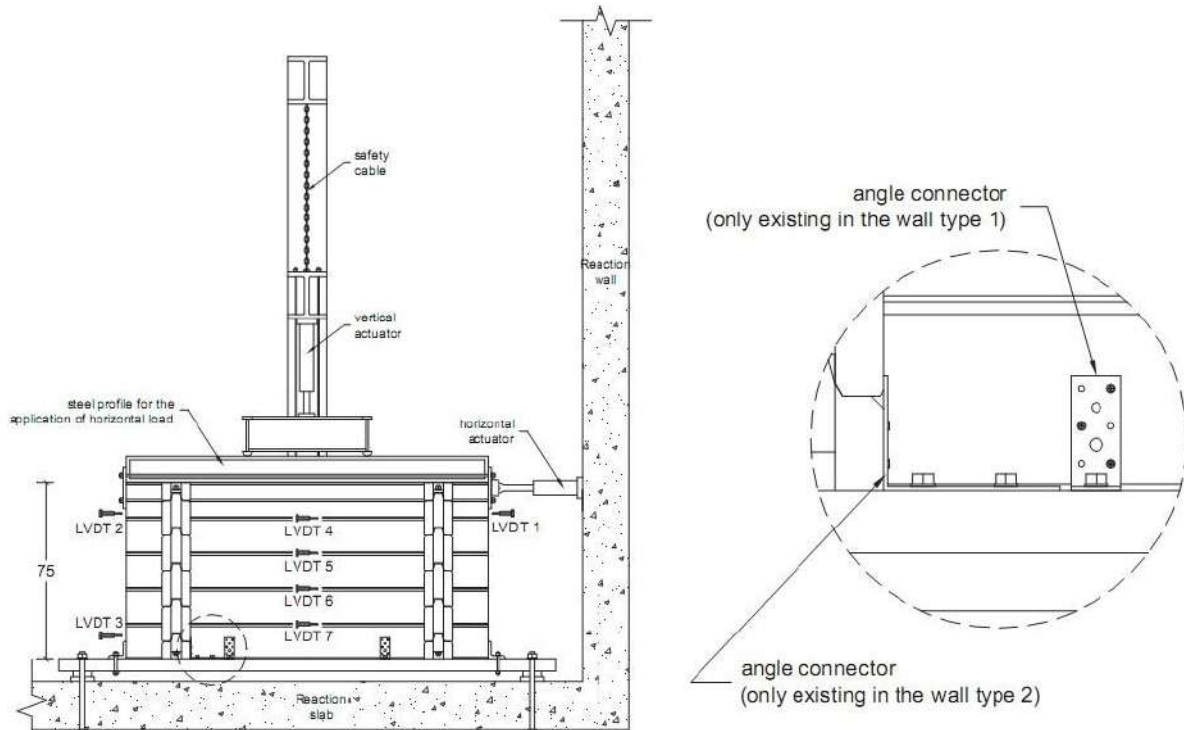
**Figure 1.3: Side view of the set-up for testing the full-scale log walls [4]**

The second phase focussed on the characterization of the behaviour of log walls by subjecting wall specimens to monotonic and cyclic loading. In order to assess the structural behaviour of log walls under lateral in-plane loads, a number of in-plane static tests were conducted on timber log walls and the effect of parameters like transversal stiffness, vertical compression, slenderness ratio was studied. Figure 1.3 shows the lateral view of the test set-up adopted for the timber log wall tests.

From the monotonic tests, it was found that the magnitude of vertical compression was proportional to the stiffness of the wall. Due to an increase in the friction between logs, the

horizontal corresponding to the initial displacement also increased, although the ultimate load remained about the same for all walls. The cyclic tests showed that the foundation connection influenced the global behaviour of the walls whereas in the monotonic tests, the global behaviour was found to be independent of the foundation connection type. It was also observed that an increase in slenderness ratio causes a reduction in the lateral resistance of the wall [4].

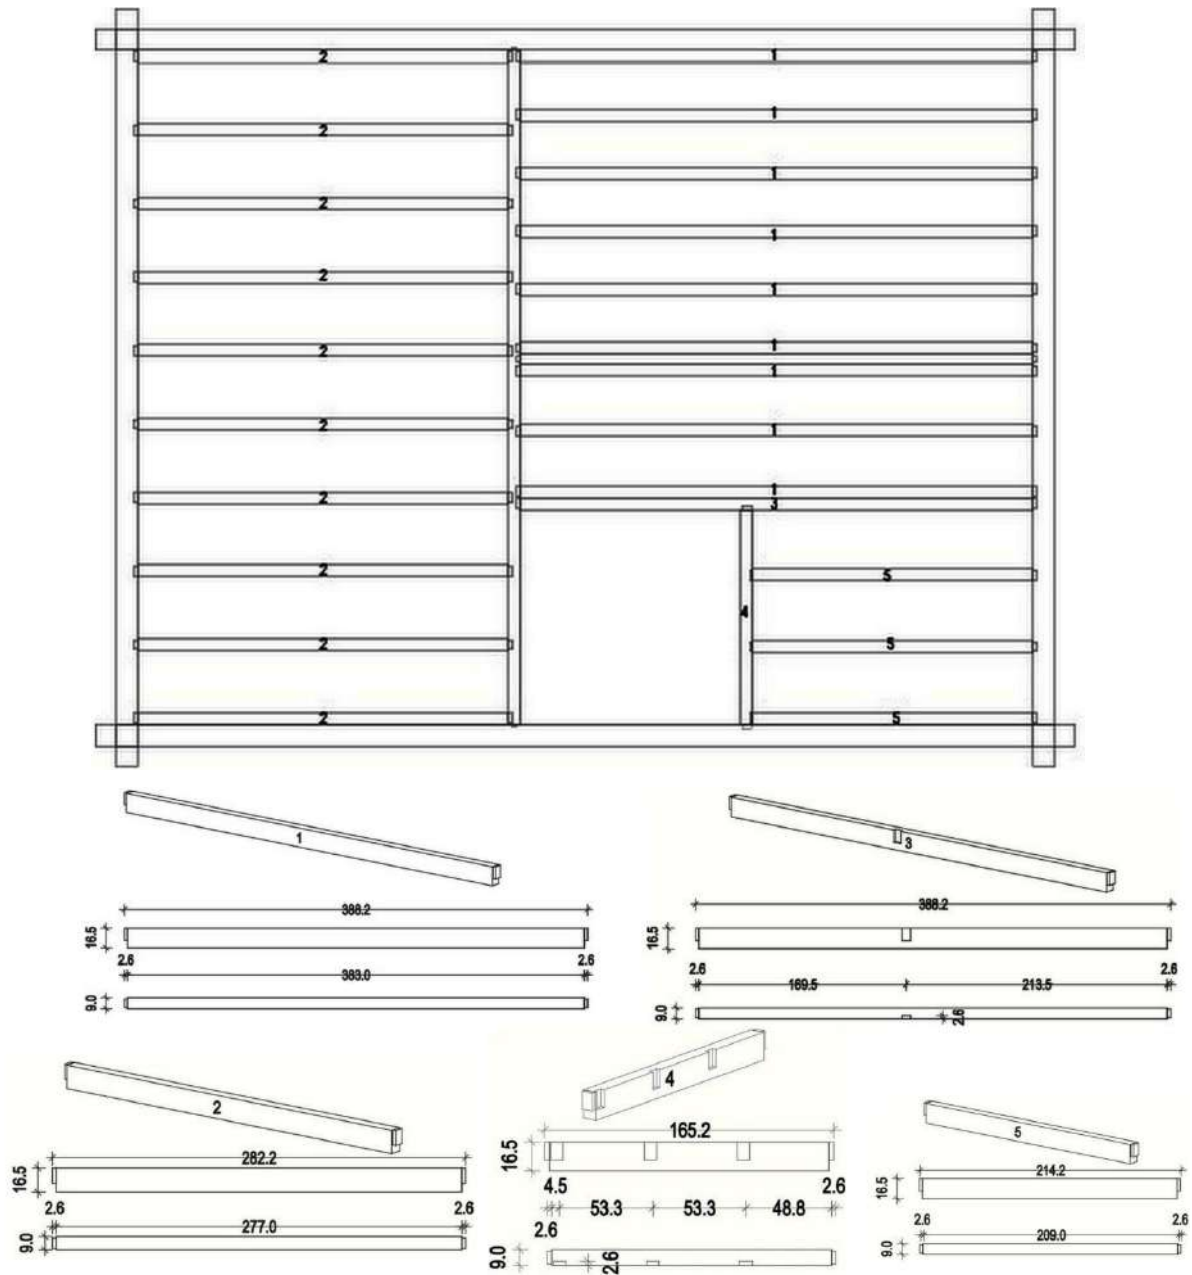
Figure 2.2: Floor beams

which are 22mm thick. In Figure 2.2, the framework of the floor beams along with their dimensions are seen.

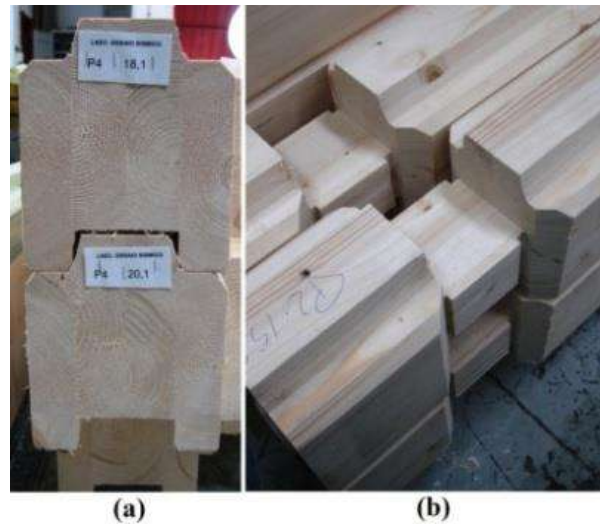
**Figure 2.5: (a) Side profile of the logs; (b) Notches at corners of external wall logs**

The logs used in the construction of the walls form a perfect fit with each other as they are shaped both at the top and bottom. The ends of the logs are notched to facilitate the intersection of the cross walls. In Figure 2.5 it is possible to see the side profile of the logs and the corner notches.

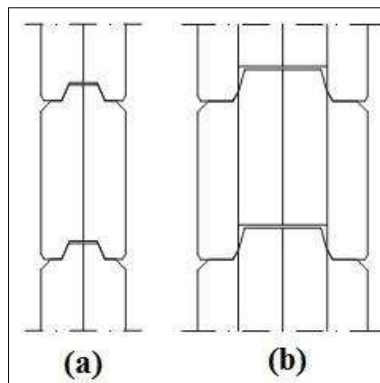
**Figure 2.6: Cross-section: (a) internal walls; (b) external walls**

The logs are made of glued and laminated timber derived from Scots Pine trees (*Pinus sylvestris* L.) and belong to the C24 class of resistance according to [5]. The properties of the wood are listed in Table 2.1. Additional information about the geometry and the mechanical characterization of the logs can be found in [6]. The dimensions of the cross sections of the logs used in the outer walls and inner walls are 160x160mm and 80x160mm respectively and can be seen in Figure 2.6. The lamellas which constitute an individual log are each 40mm thick. The inner walls are composed of logs that have two lamellas while the outer walls are composed of four lamellas.

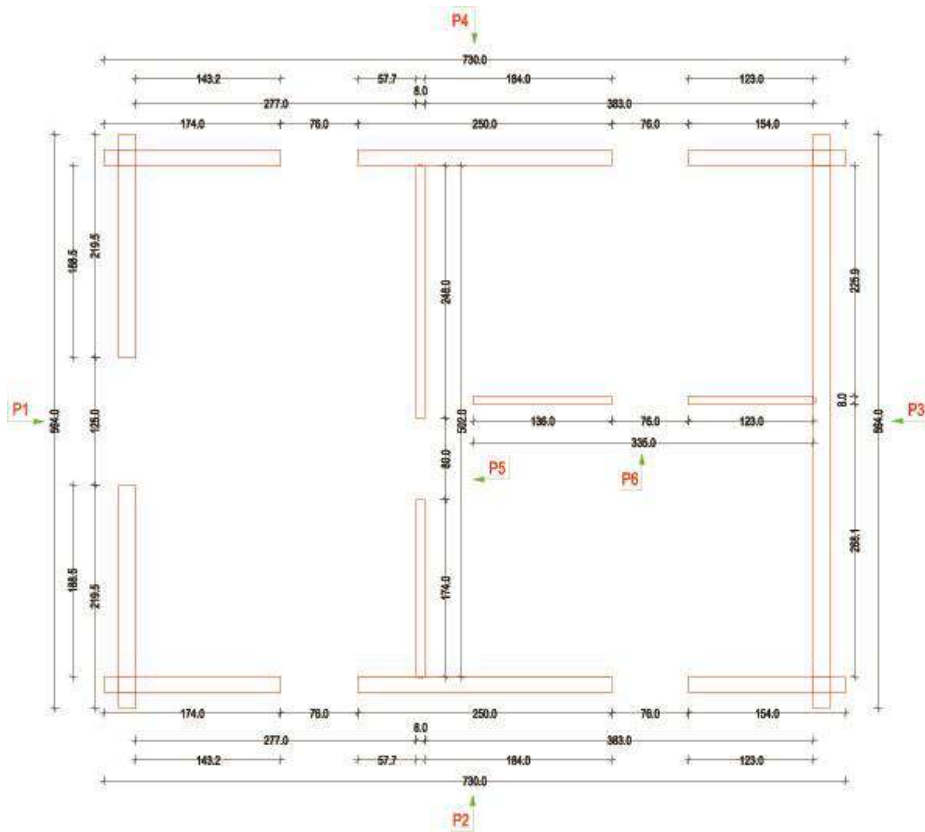
Figure 2.7: Ground floor plan

All the walls of the building have been provided with openings to study their influence on the seismic behaviour of the house. In the case of walls provided with openings on both the floors, they are aligned one above the other. The external walls in the longitudinal direction (P2 and P4) have identical openings, with a window and a door on the ground floor and two windows in the upper storey. One of the external walls in the transverse direction (P1) has a door provided on each floor while the other one (P3) has two windows provided on the upper floor. Both the internal walls (P5 and P6) are provided with a door on each floor. The inner wall in the longitudinal direction is connected with the exterior wall (P3) only along one edge to minimize the effect of wall linkages. The plan of the ground floor along with the dimensions is seen Figure 2.7 and Figure 2.8 show the plan of the first floor.

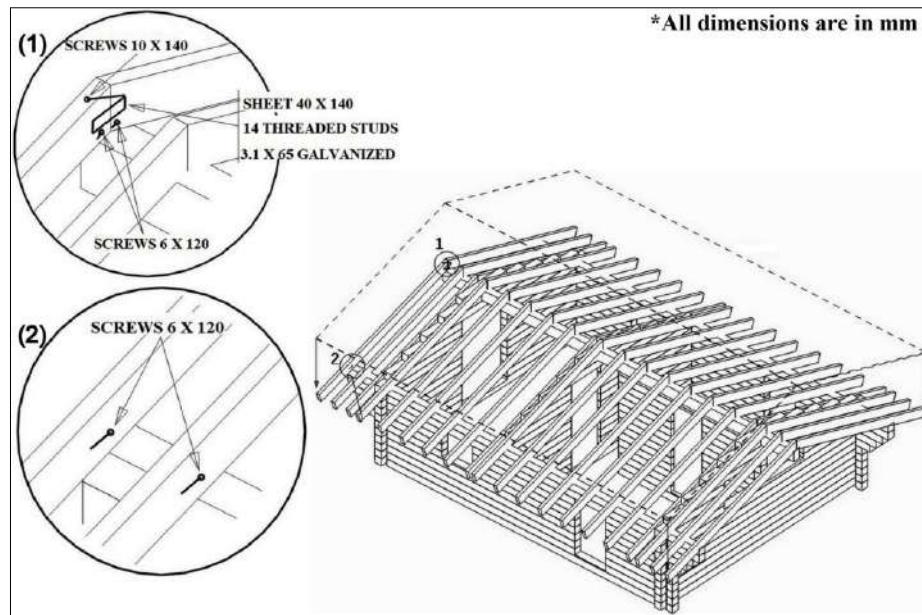
**Figure 2.10: Roof connections**

The fasteners used in the roof are screws of 10x140mm along with a metal sheet of size 40x140mm at the ridge and screws of size 6x120mm are drilled at the top and bottom of the rafters (Figure 2.10).

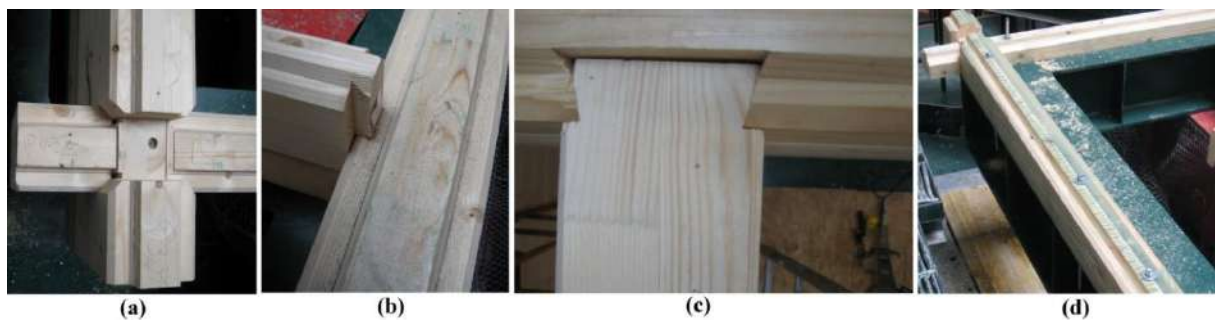
**Figure 2.11: Connections between: (a) two exterior walls; (b) an exterior and an interior wall; (c) floor end joist and wall; (d) sill log and foundation**

The sill logs are connected to the steel plate through M16 bolts of Class 8.8 that are spaced at intervals of 500mm. This ensures that the sliding between the log house and the steel lattice is minimal. The connections between wooden members are in the form of halved joints when two exterior walls meet orthogonally and dovetail joints when an exterior wall meets an interior wall. The floor end joists are also appropriately grooved to form dovetail joints with the log walls. The connections between wooden members and the base log and foundation can be seen Figure 2.11.

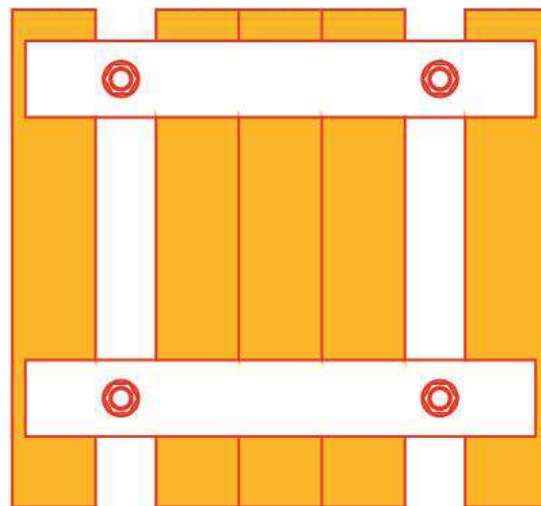
**Figure 2.12: A representation of the steel mass used as additional weight**

Since the building did not incorporate any non-structural component and was constructed without any finish, additional masses were placed in order to simulate the permanent loads and accidental loads. Two steel masses weighing 600kg each were attached to the floor to represent floor loads. A representative steel platform is seen in Figure 2.12.

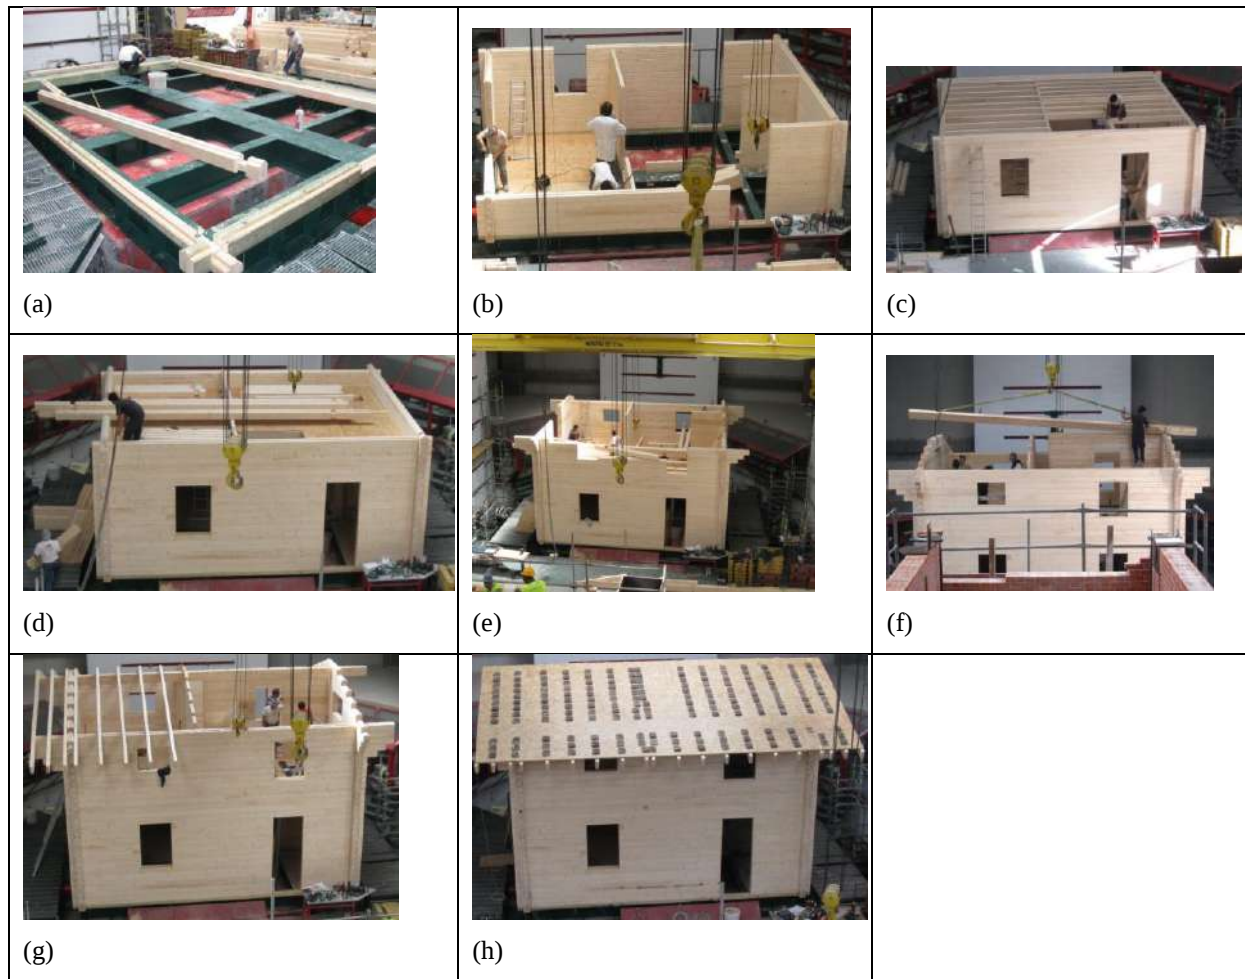
**Figure 2.14: Stages of construction: (a) connecting the bottom logs with the steel lattice; (b) laying the ground floor walls; (c) placing floor beams; (d) nailing OSB planks to the floor joists; (e) laying the first floor walls; (f) positioning the ridge board; (g) connecting the roof rafters; (h) Completed house**

The construction process of the house proceeded in the following manner. After connecting the steel base to the shaking table, the bottom logs were placed on the edges of the lattice and connected via anchor bolts. Successive logs were then laid in all the walls simultaneously up to the level of the floor. The floor beams were laid out as per the plans and screws were drilled at the intersections with the internal walls. Once all the floor beams had been fixed and the mechanical fasteners had been driven in, the OSB panels superposed on the floor beams and nailed in place. The additional masses in the form of steel platforms were then transferred on to the floor using the crane. The walls of the first floor were then built as before. The ridge board was placed along the longitudinal direction along the slots provided in the transverse walls. When all the walls were constructed, the roof rafters were laid out and screwed in. The rafters were superposed by OSB panels and finally the steel plates were nailed to the panels. Figure 2.14 shows the sequence of construction of the log house.

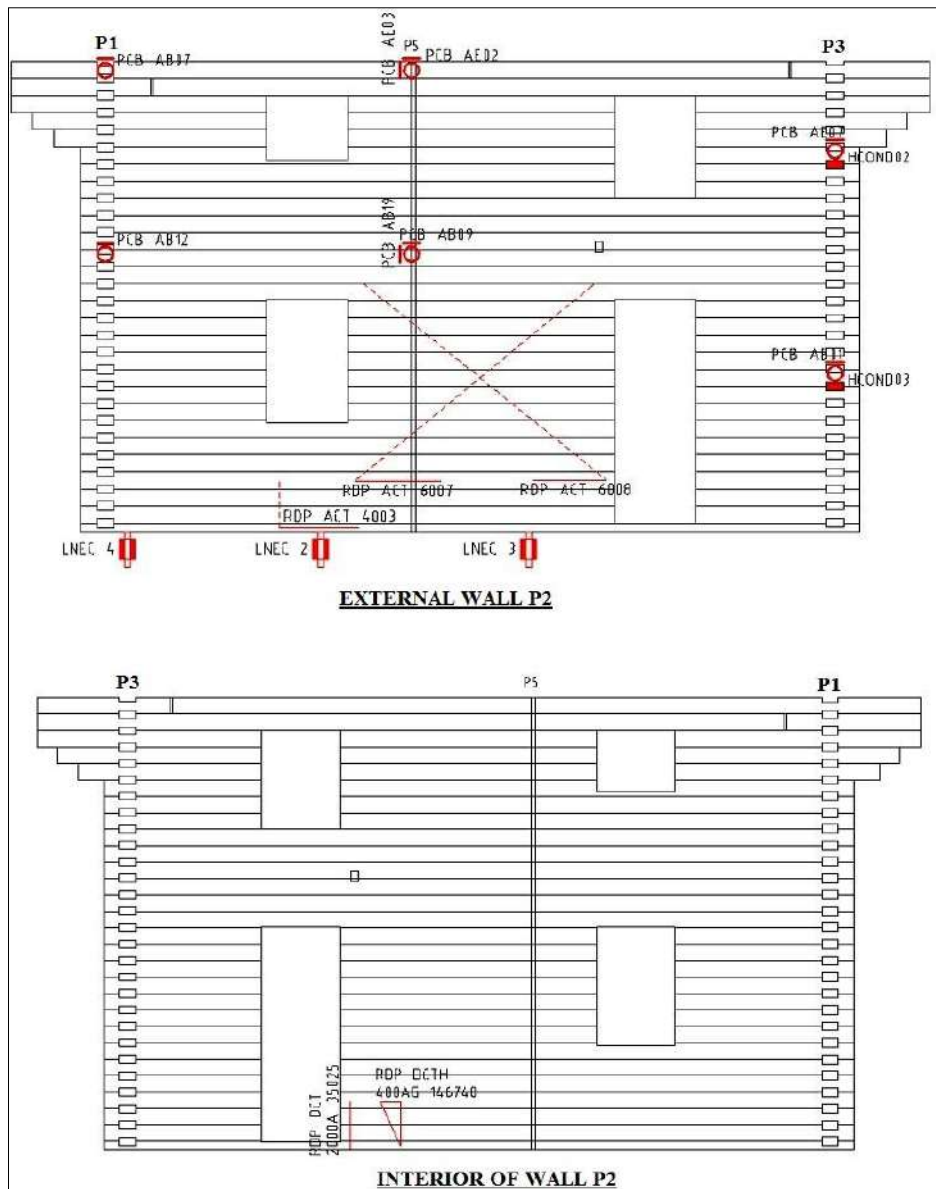
Figure 3.2: Instrumentation to monitor wall P2

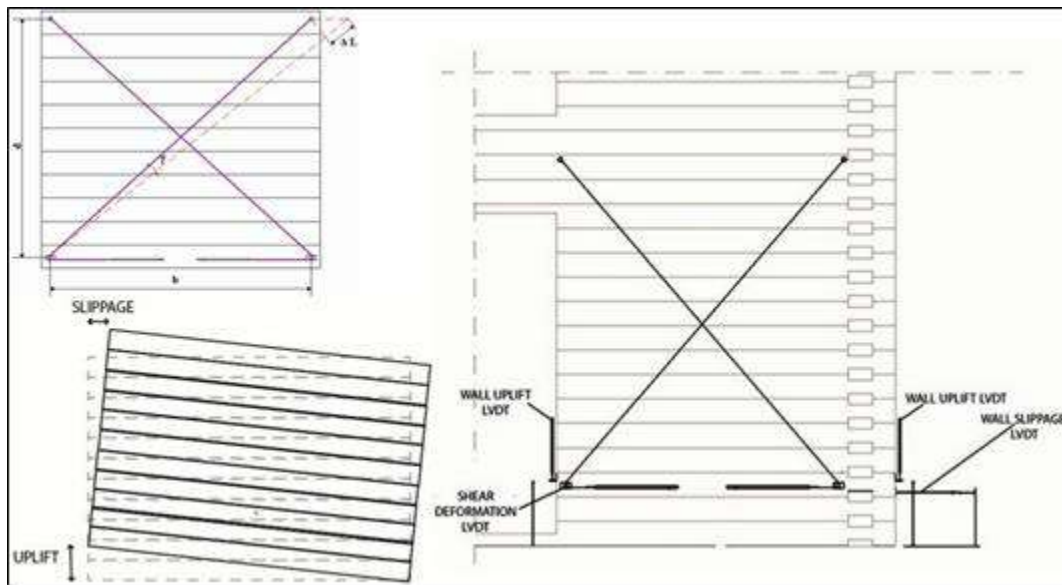
**Figure 3.8: Possible wall movements measured by the LVDT**

When a house is subjected to seismic loads, it can induce vertical and horizontal movements in the house. Lateral forces try to lift the house and cause sliding. These LVDT were placed in contact with a triangular wooden element extending from the sill log to the third log and the wall uplift LVDT were mounted on pulleys and steel cables in a manner as seen in Figure 3.8 and Figure 3.9.

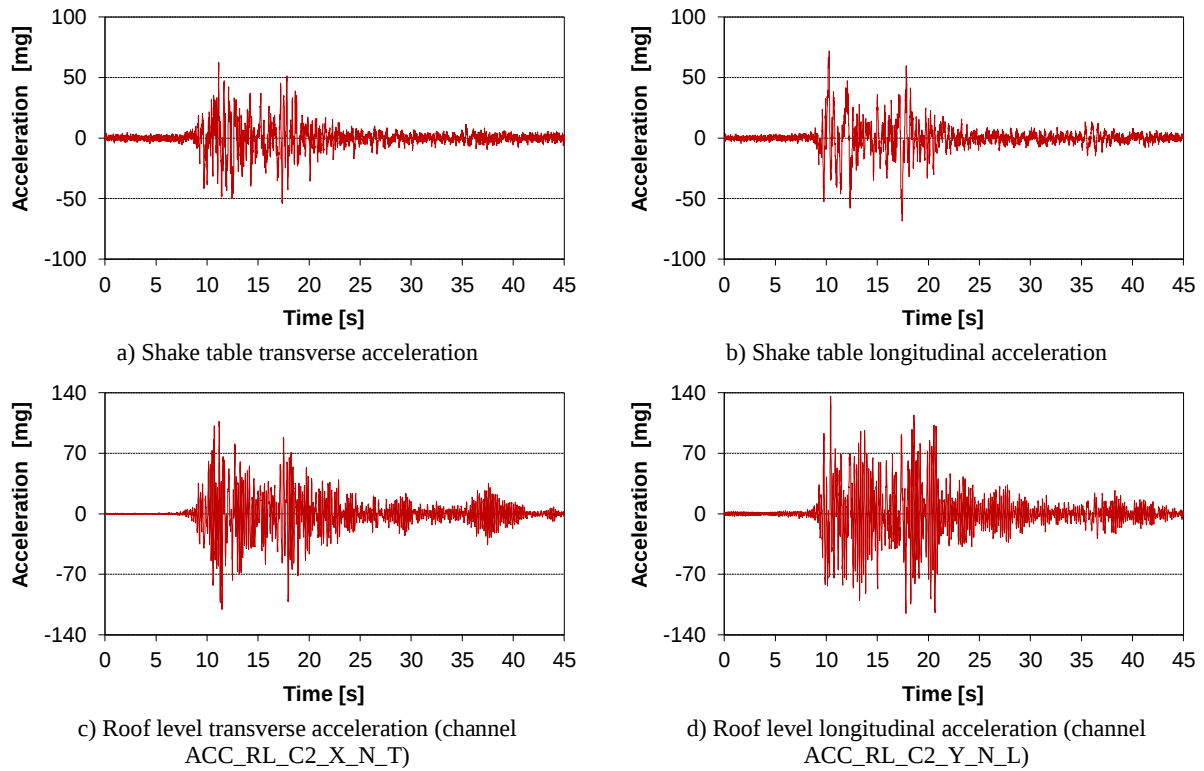
**Figure 5.4: Sample of the records obtained in seismic test TEST\_04 of the Rusticasa building**

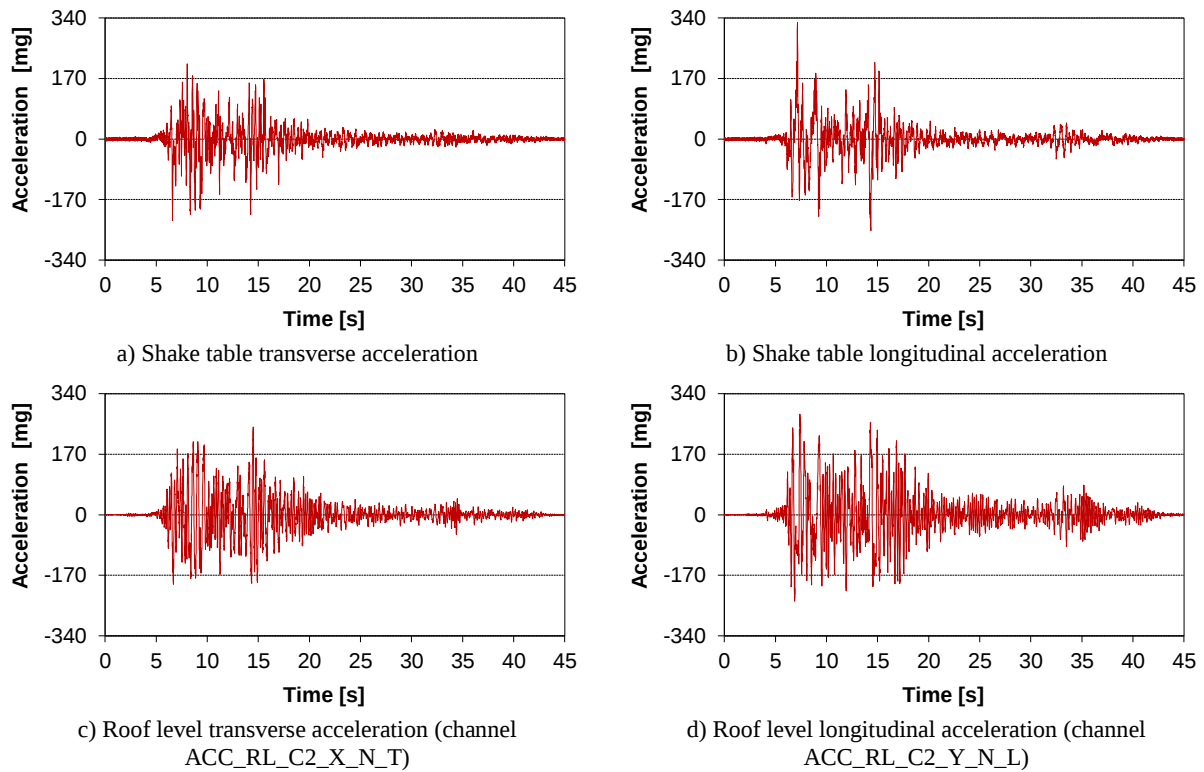
**Figure 5.5: Sample of the accelerations records obtained in seismic test TEST\_09 of the Rusticasa building**

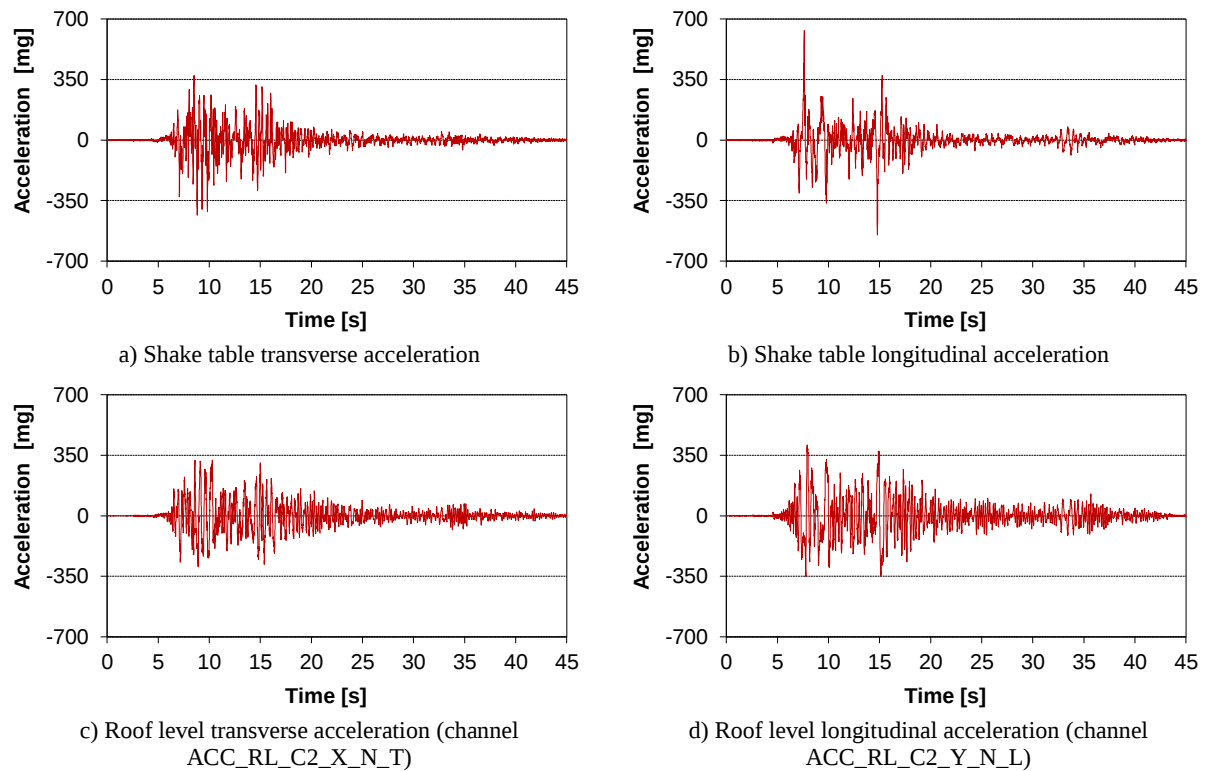
Figure 5.6: Sample of the accelerations records obtained in seismic test TEST\_11 of the Rusticasa building

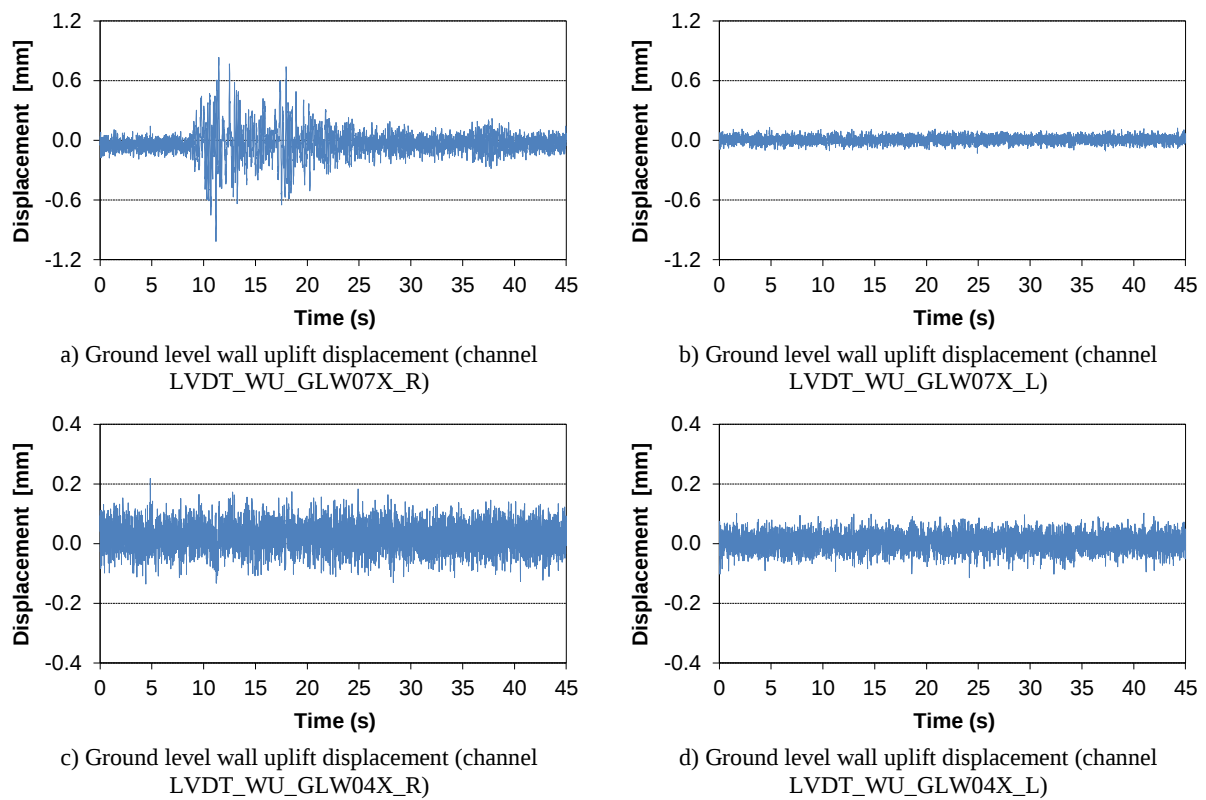
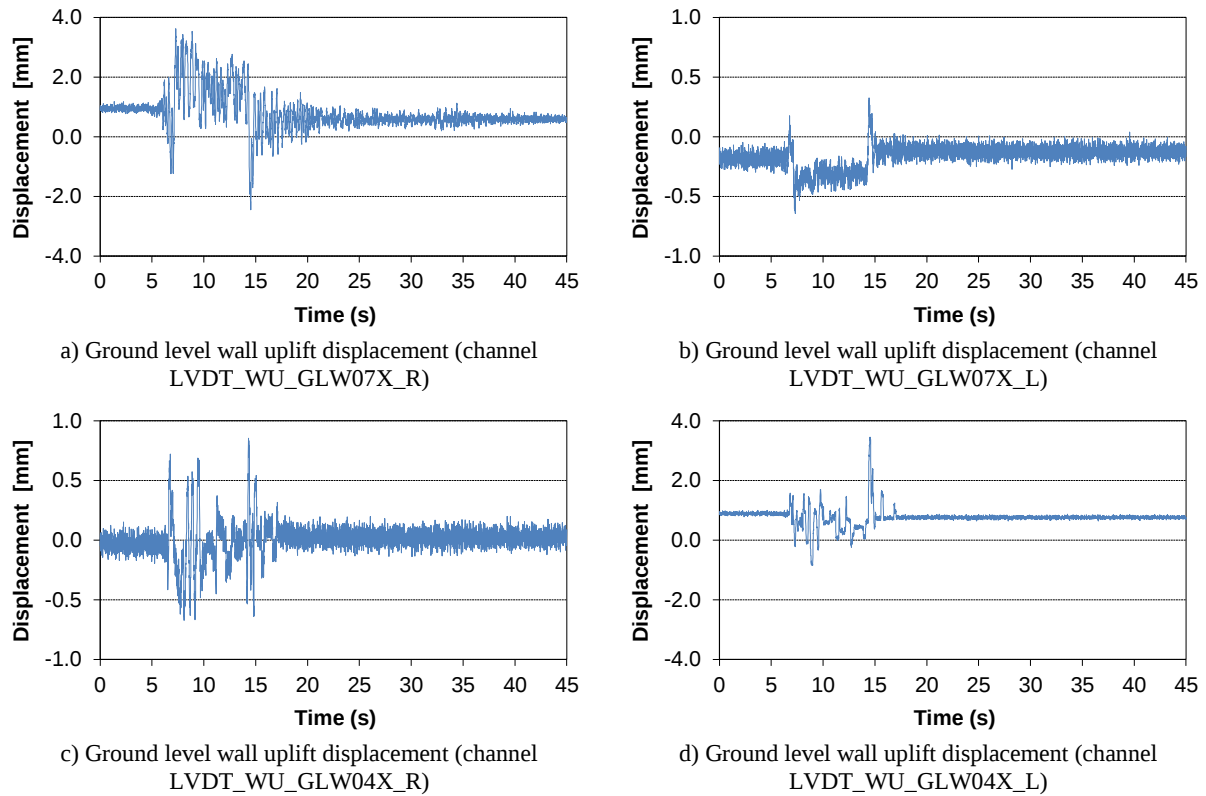
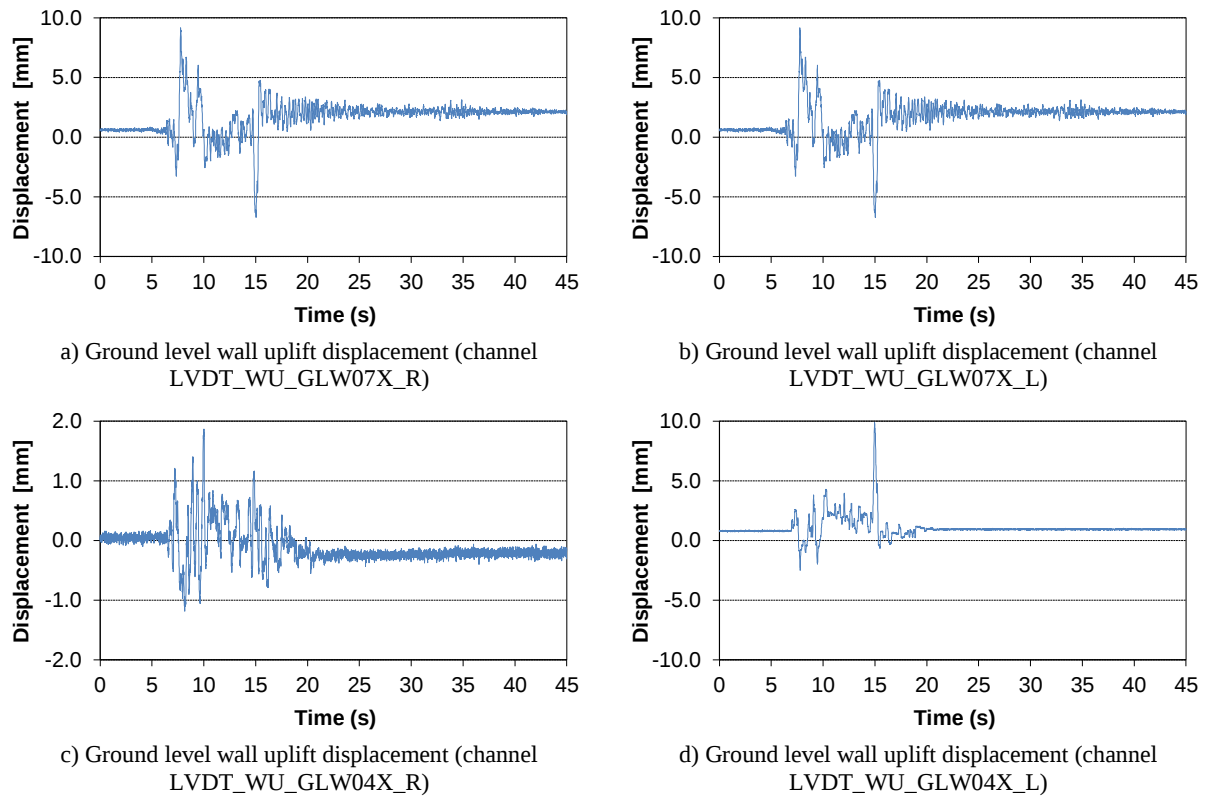
Figure 5.8: Sample of the wall uplift records obtained in seismic test TEST\_04 of the Rusticasa building

**Figure 5.9: Sample of the wall uplift records obtained in seismic test TEST\_09 of the Rusticasa building**

**Figure 5.10: Sample of the wall uplift records obtained in seismic test TEST\_11 of the Rusticasa building**

Figure 5.8 to Figure 5.10 show a small sample (four channels) of the ground level wall uplift displacements recorded in seismic tests TEST\_04, TEST\_09 and TEST\_11.

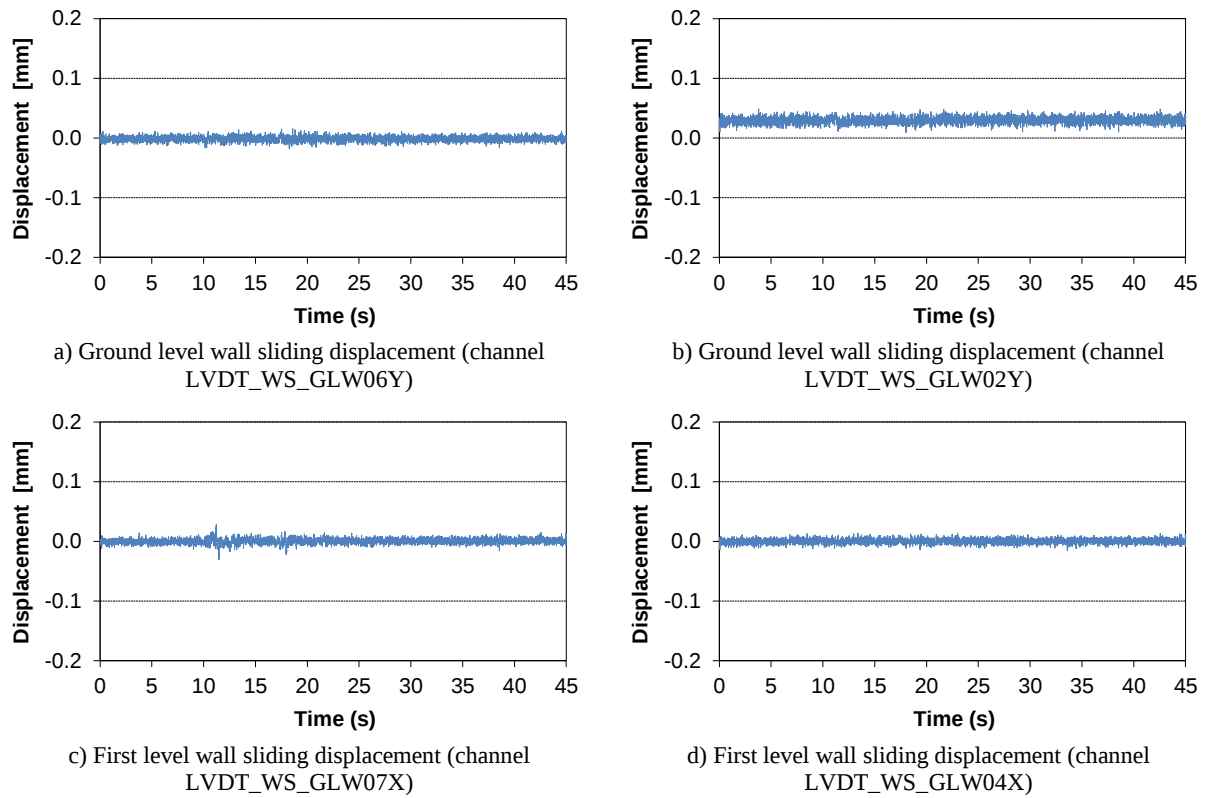
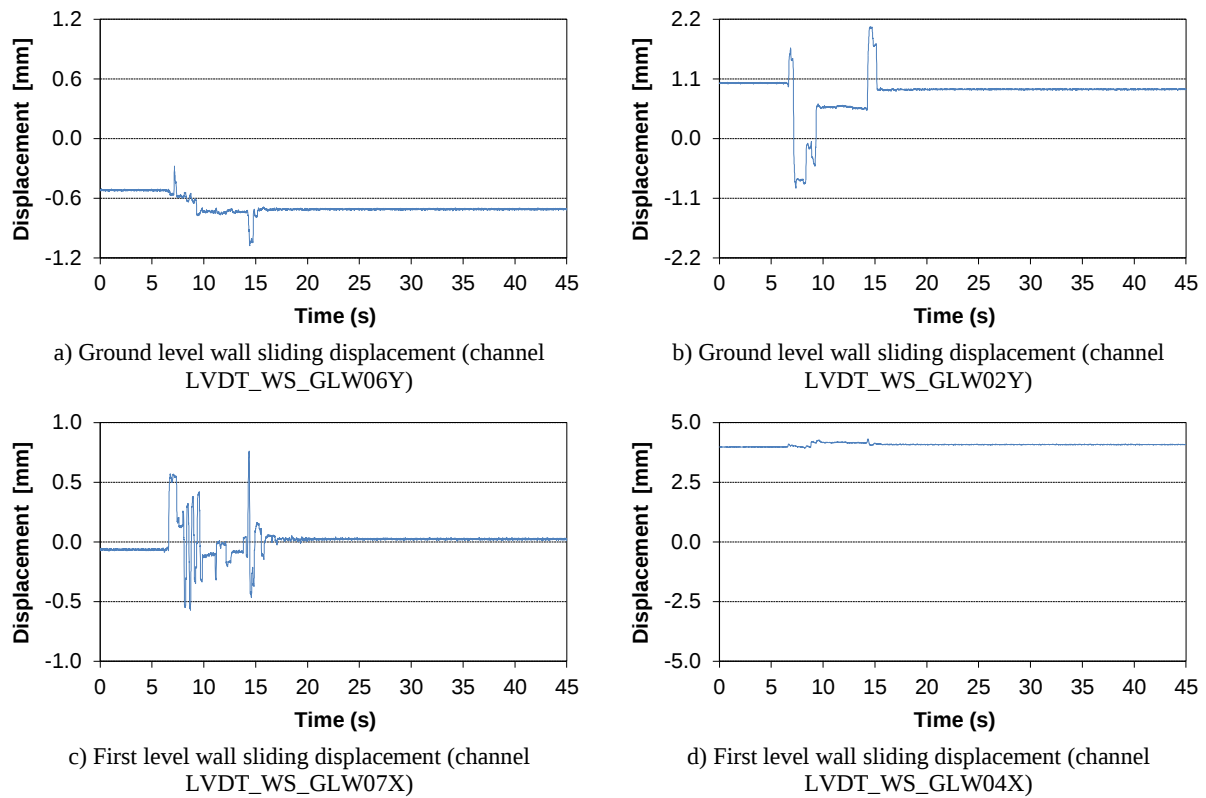
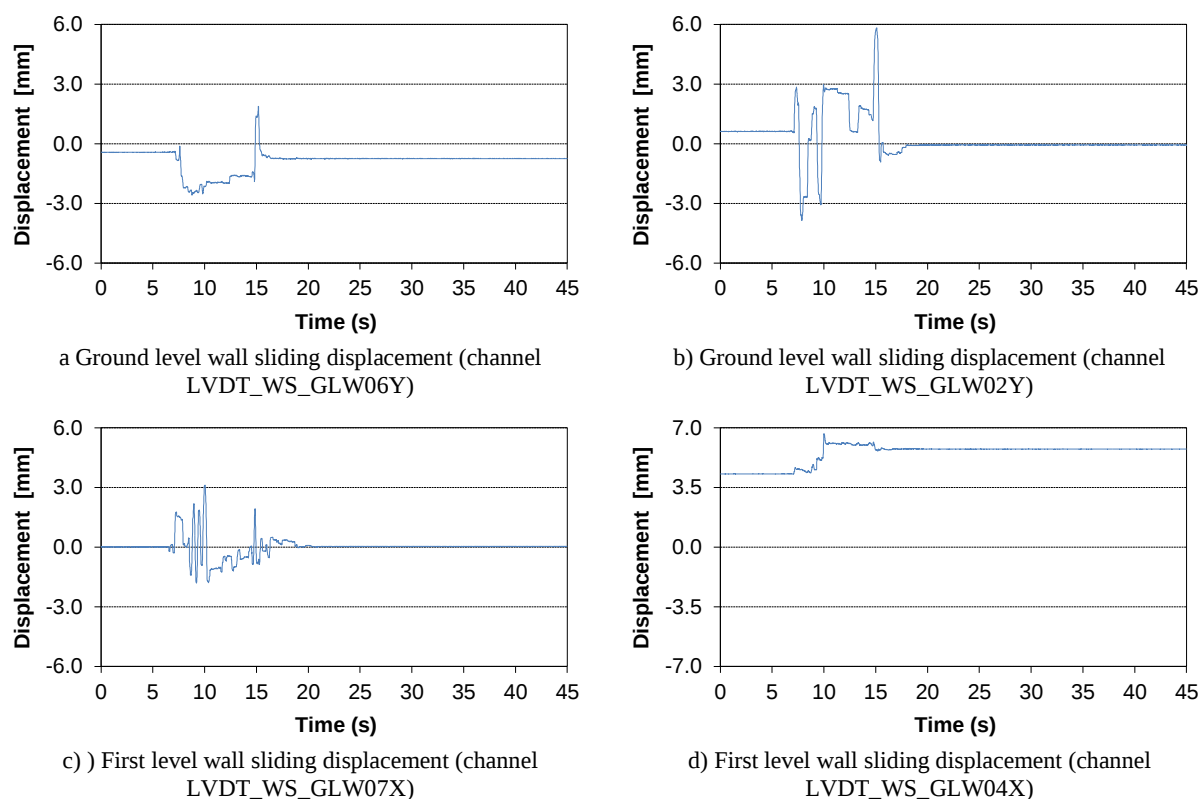
**Figure 5.12: Sample of the wall sliding records obtained in seismic test TEST\_04 of the Rusticasa building**

**Figure 5.13: Sample of the wall sliding records obtained in seismic test TEST\_09 of the Rusticasa building**

**Figure 5.14: Sample of the wall sliding records obtained in seismic test TEST\_11 of the Rusticasa building**

Figure 5.12 to Figure 5.14 show a small sample (four channels) of the ground and first levels wall sliding displacements recorded in seismic tests TEST\_04, TEST\_09 and TEST\_11.

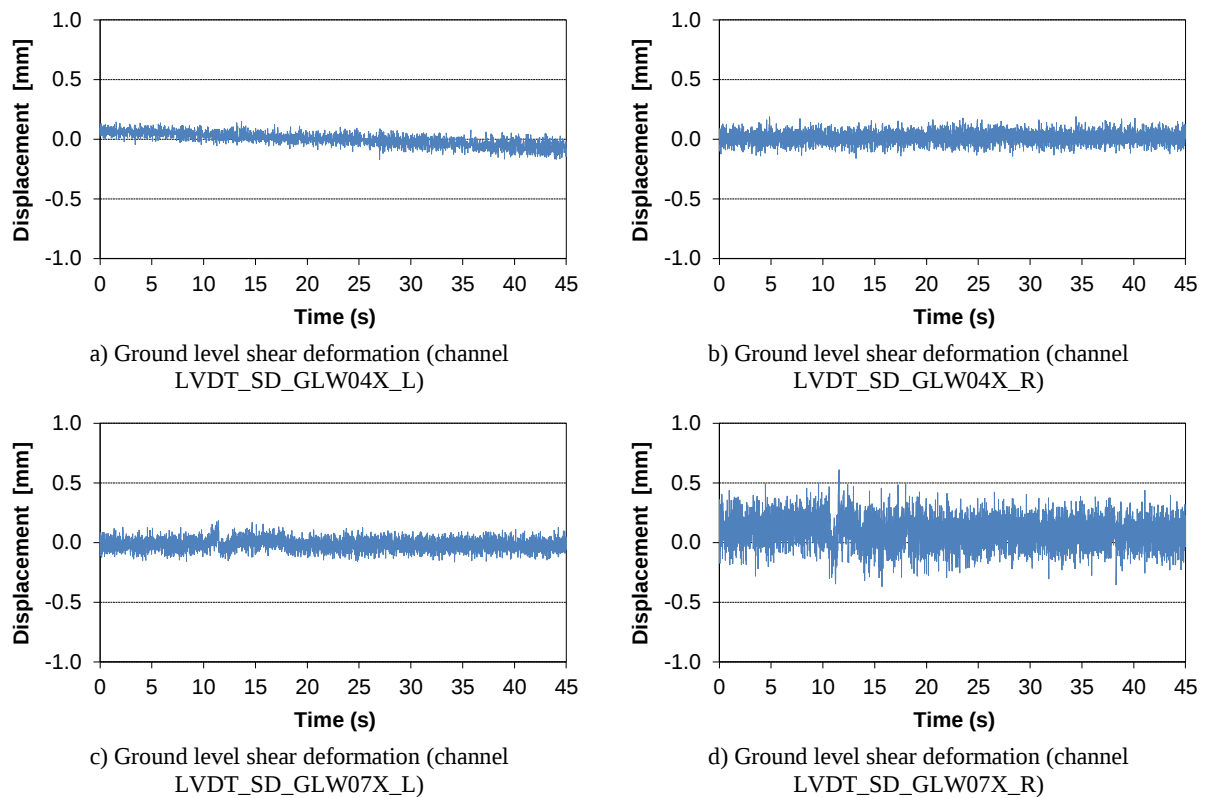
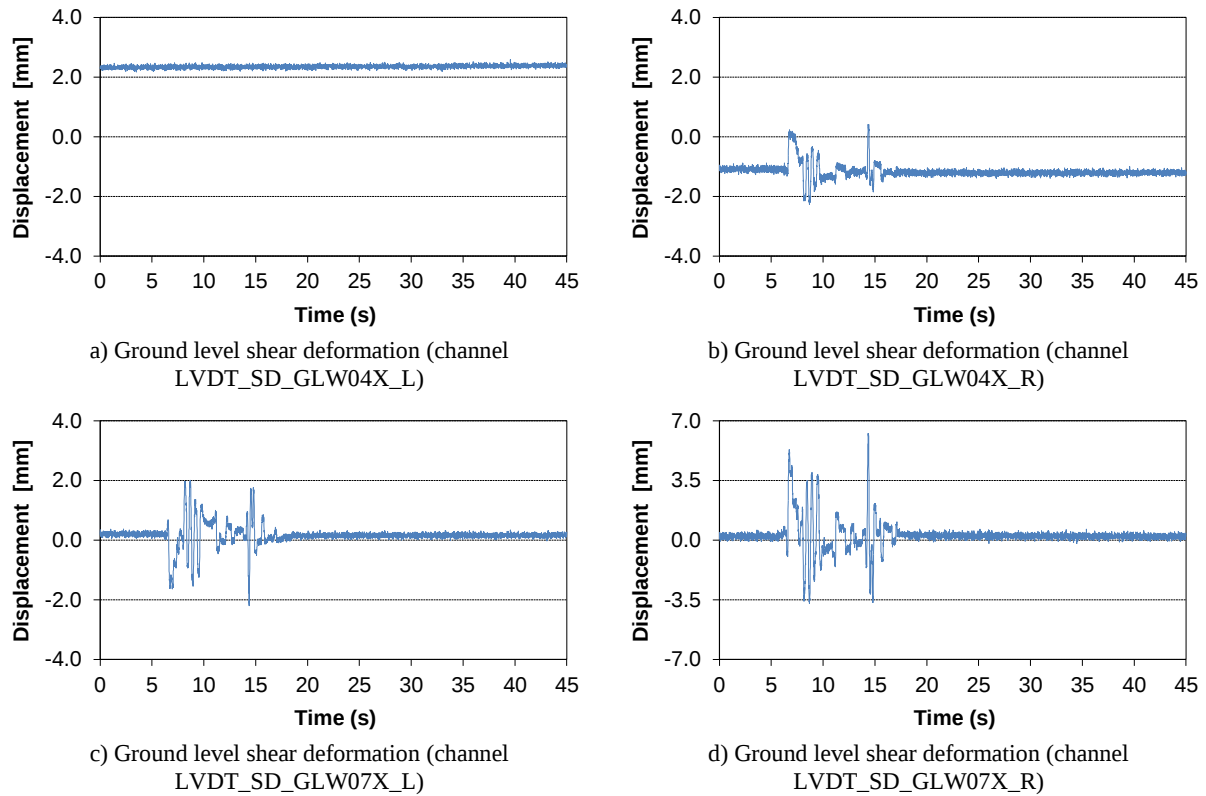
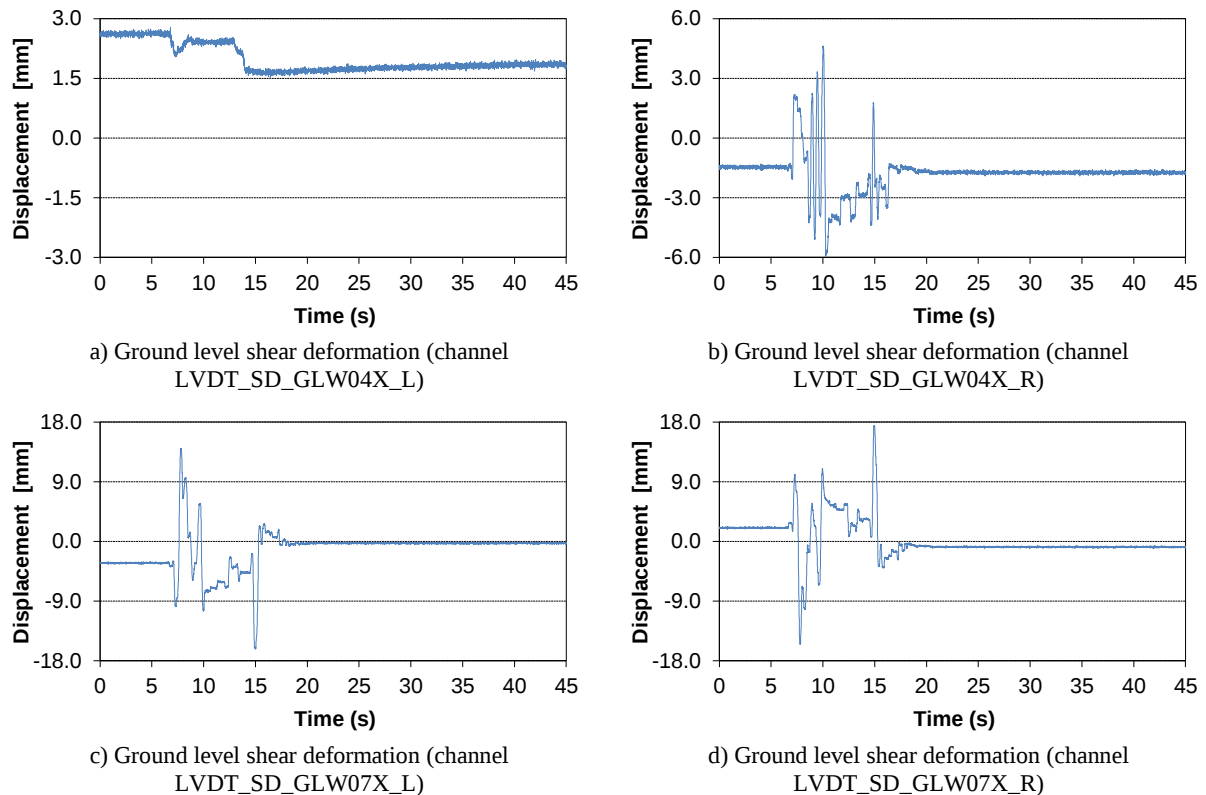
Figure 5.16: Sample of the shear deformation records obtained in seismic test TEST\_04 of the Rusticasa building

**Figure 5.17: Sample of the shear deformation records obtained in seismic test TEST\_09 of the Rusticasa building**

**Figure 5.18: Sample of the shear deformation records obtained in seismic test TEST\_11 of the Rusticasa building**

Figure 5.16 to Figure 5.18 show a small sample (four channels) of the ground and first levels shear deformation recorded in seismic tests TEST\_04, TEST\_09 and TEST\_11.
