# **SERIES**

## **SEISMIC ENGINEERING RESEARCH INFRASTRUCTURES FOR EUROPEAN SYNERGIES**

### **SEISMIC PERFORMANCE OF MULTI-STOREY TIMBER BUILDINGS**

#### **Rusticasa building**

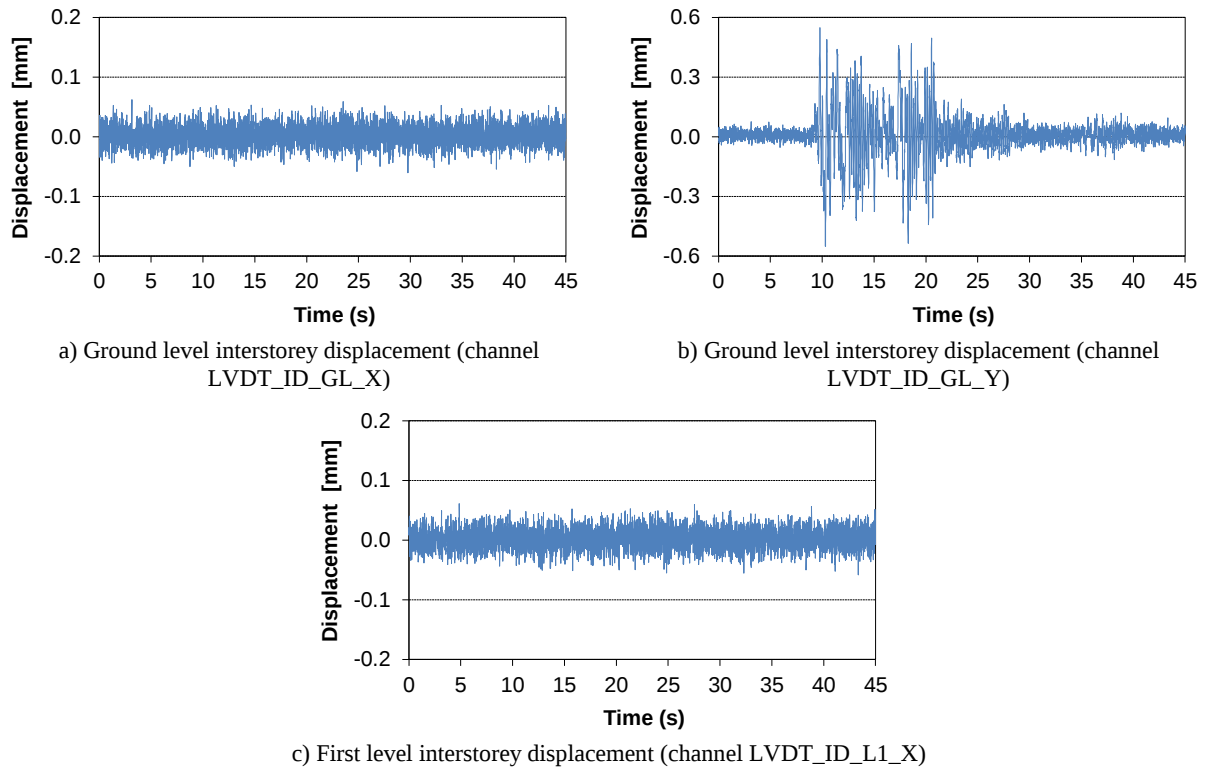
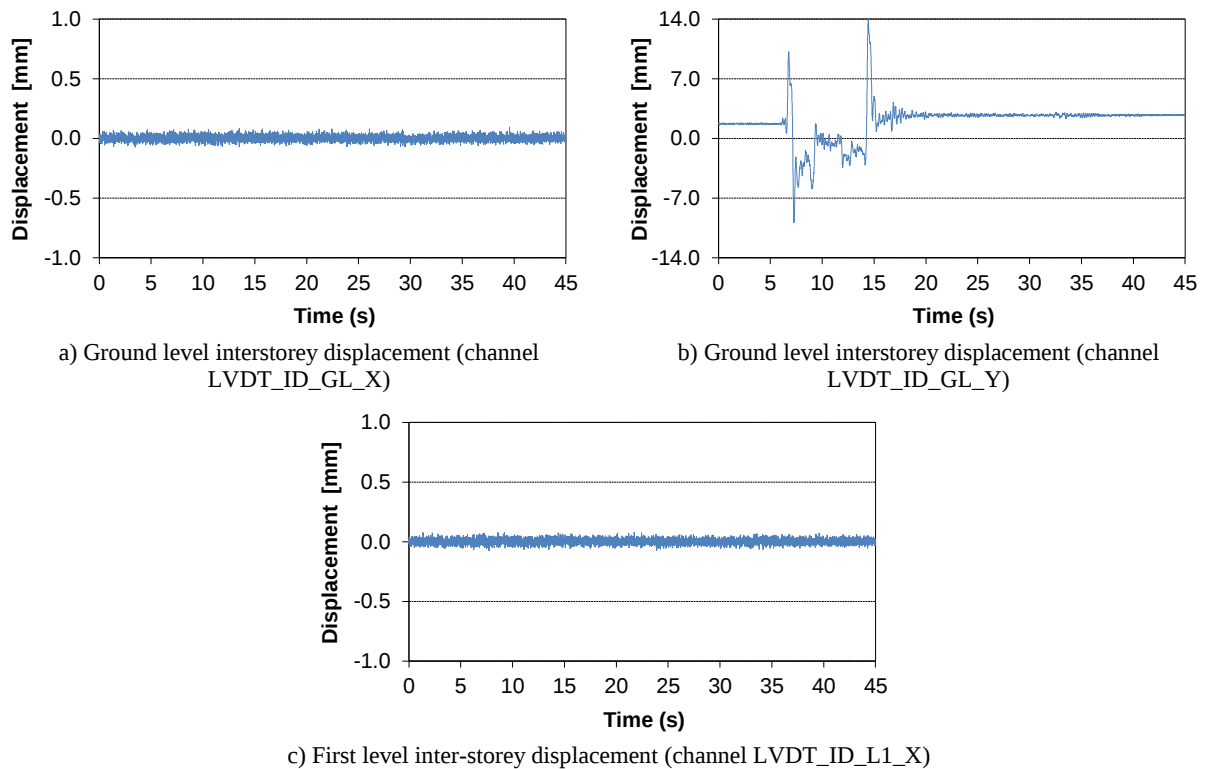
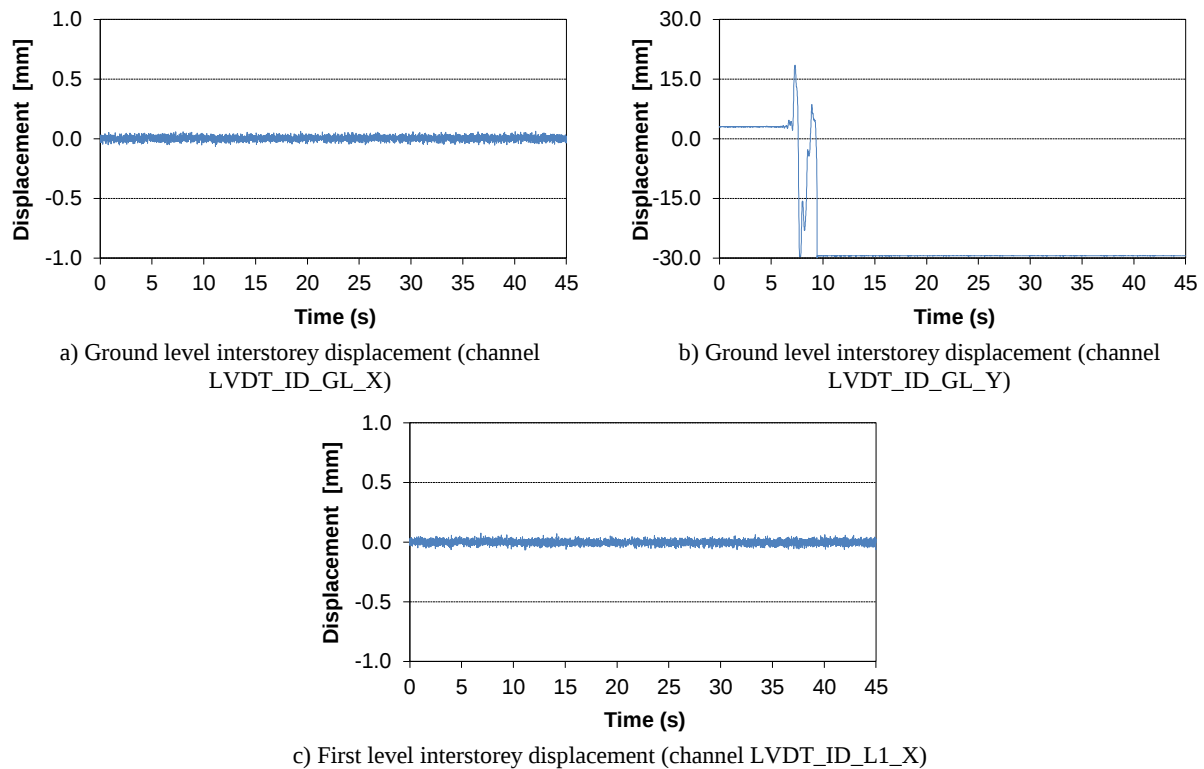
**Figure 5.19: Sample of the inter-storey drift records obtained in seismic test TEST\_04 of the Rusticasa building**

**Figure 5.20: Sample of the inter-storey drift records obtained in seismic test TEST\_09 of the Rusticasa building**

**Figure 5.21: Sample of the inter-storey drift records obtained in seismic test TEST\_11 of the Rusticasa building**

Figure 5.19 to Figure 5.21 show a small sample (four channels) of the ground and first levels inter-storey drift displacements recorded in seismic tests TEST\_04, TEST\_09 and TEST\_11.

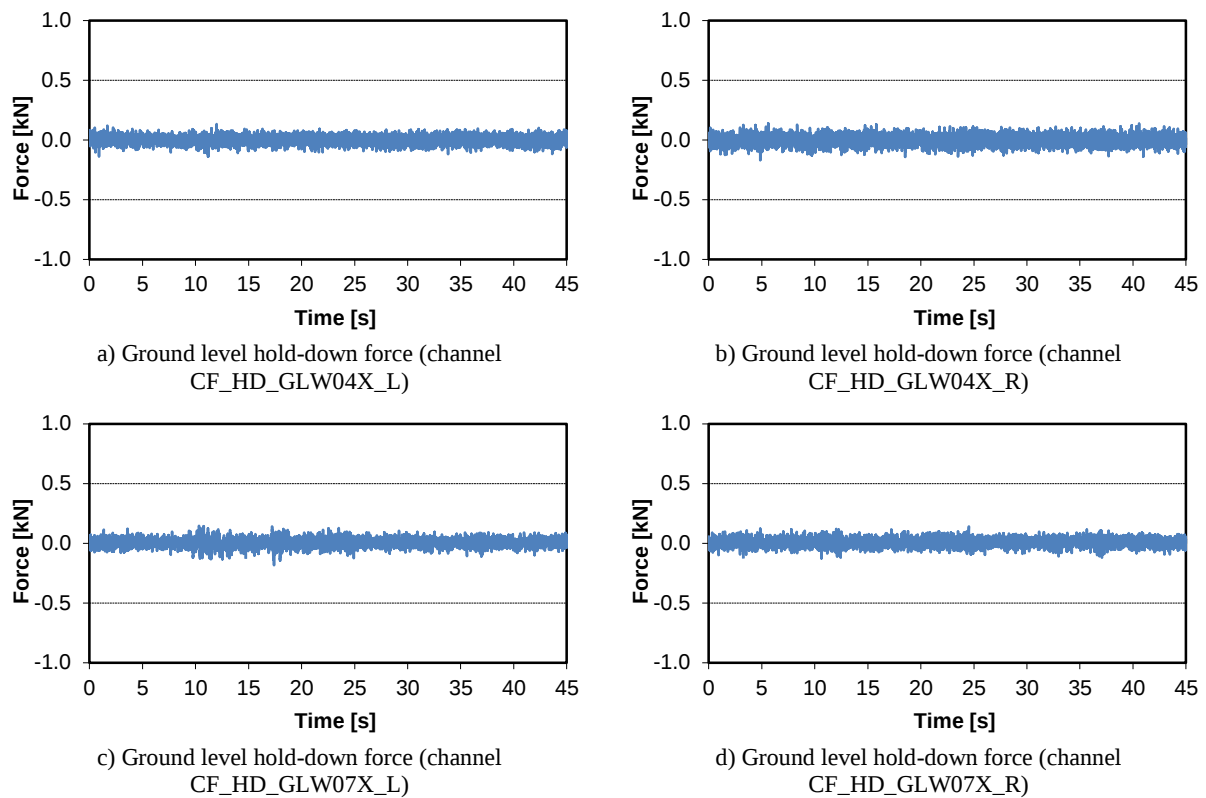
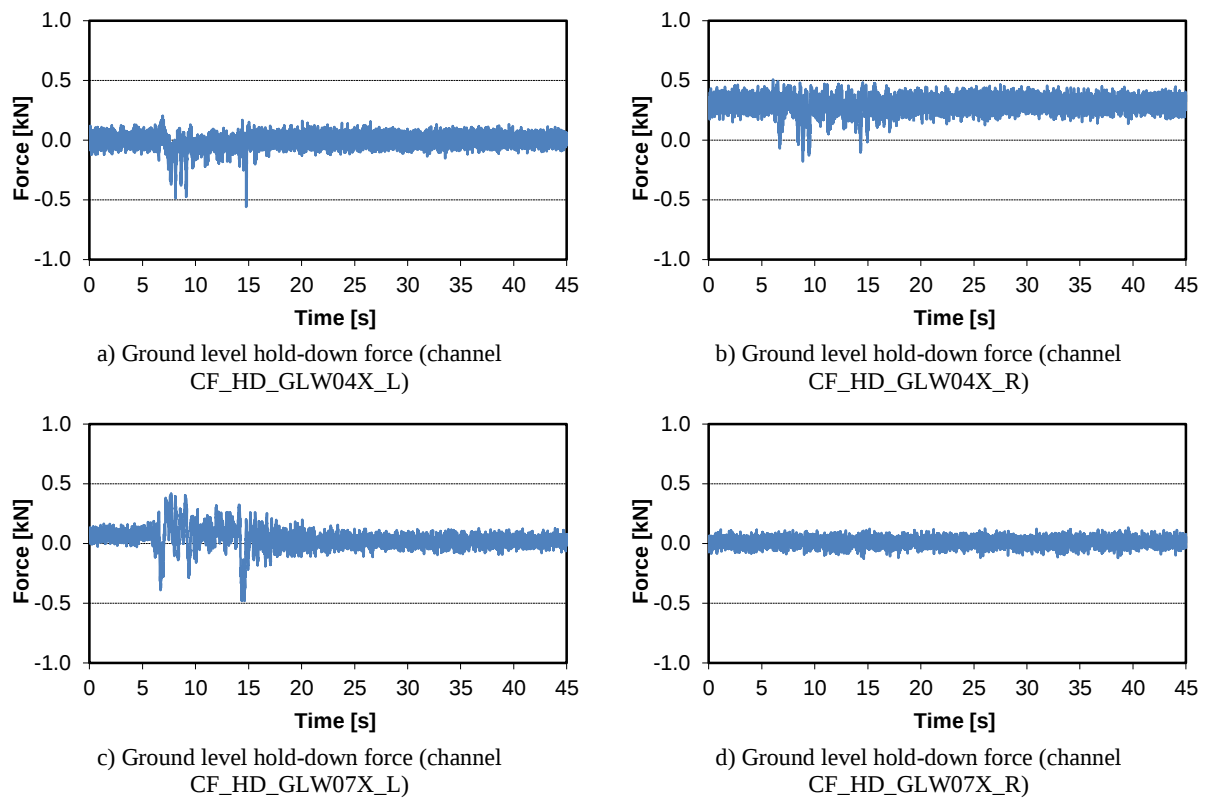
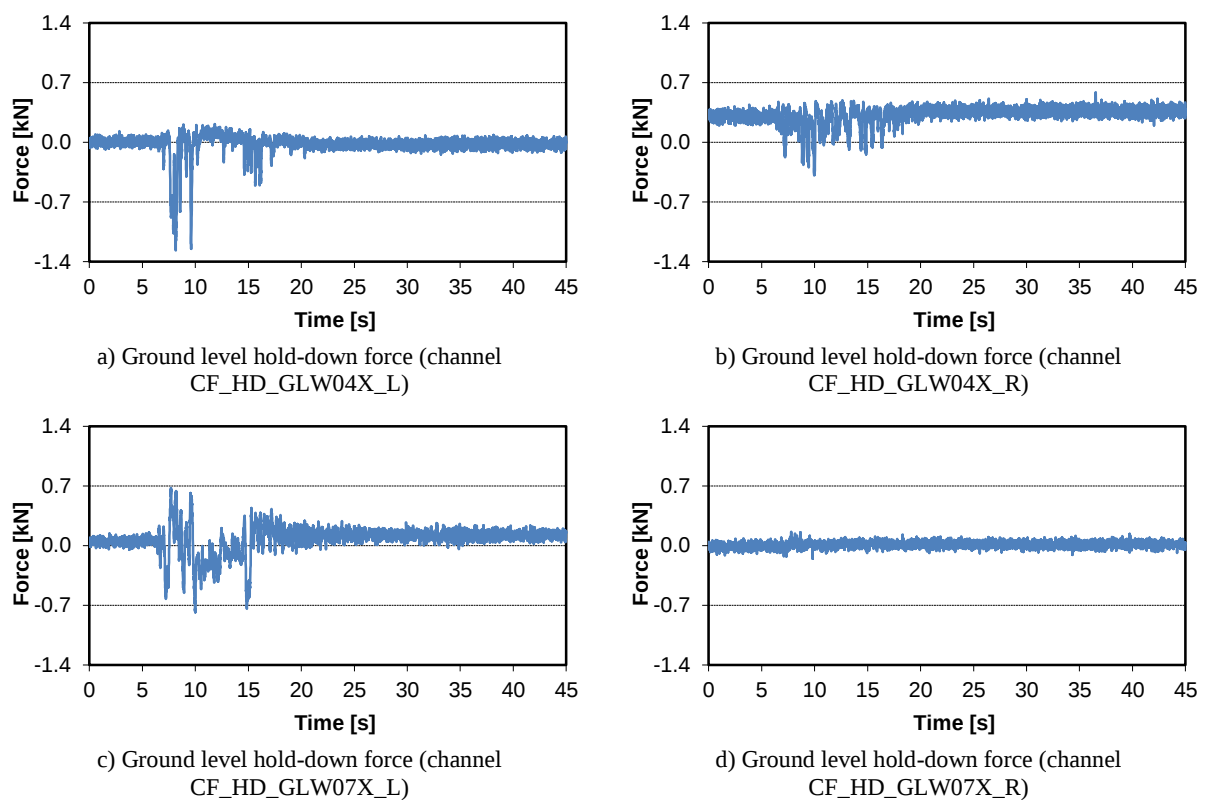
Figure 5.23: Sample of the hold-down forces records obtained in seismic test TEST\_04 of the Rusticasa building

**Figure 5.24: Sample of the hold-down forces records obtained in seismic test TEST\_09 of the Rusticasa building**

**Figure 5.25: Sample of the hold-down forces records obtained in seismic test TEST\_11 of the Rusticasa building**

Figure 5.23 to Figure 5.25 show a small sample (four channels) of hold-down forces recorded in seismic tests TEST\_04, TEST\_09 and TEST\_11.

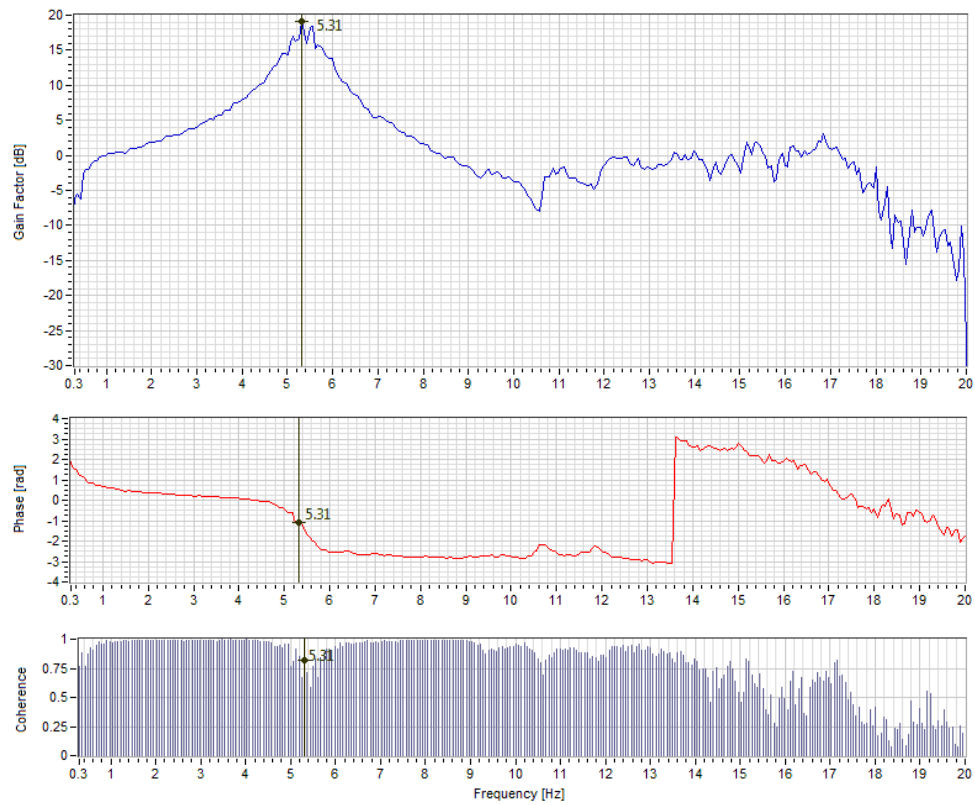
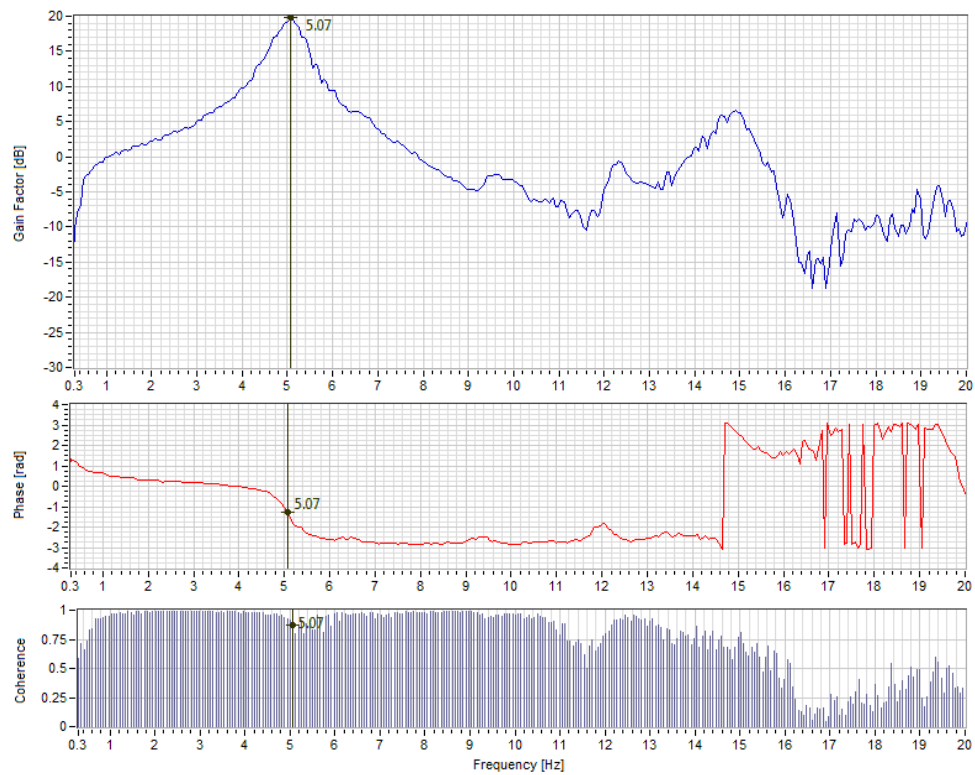
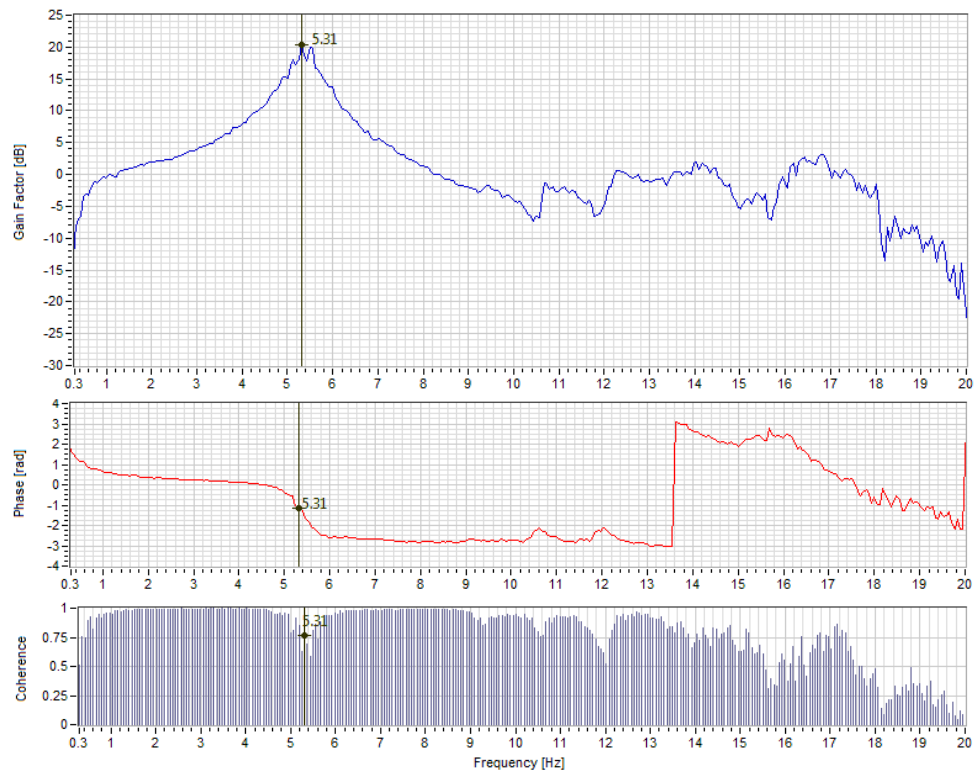
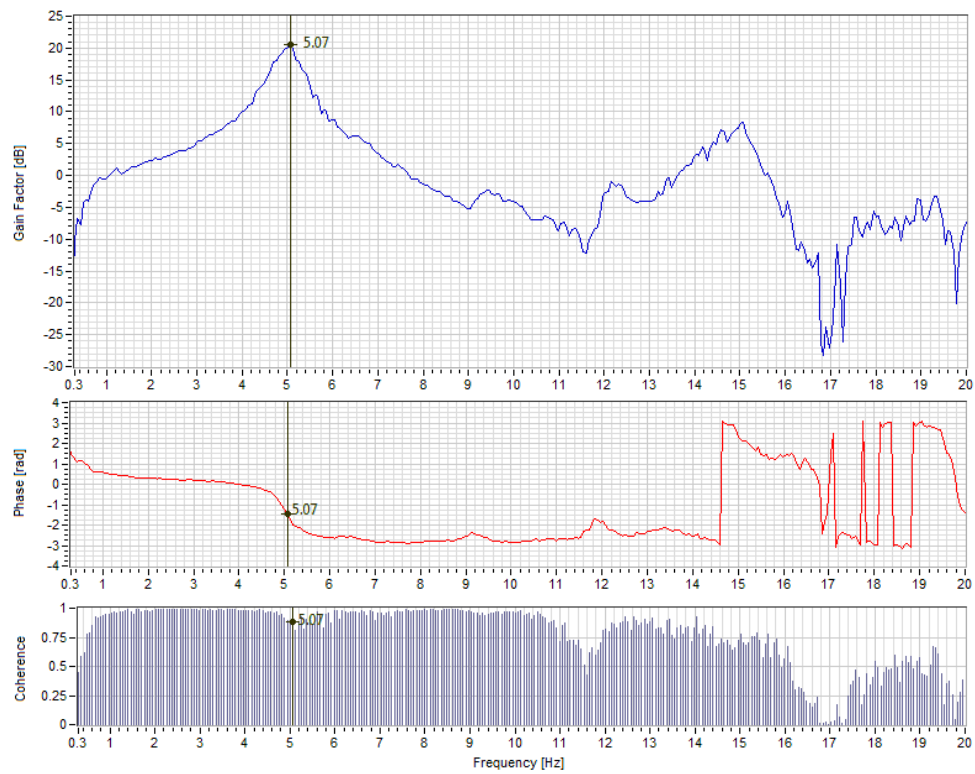
**Figure 5.36: Frequency response function, phase and coherence (Cat 1): ACC MESA TRANS; ACC\_RL\_B2\_X\_I\_T**

**Figure 5.37: Frequency response function, phase and coherence (Cat 1): ACC MESA LONG; ACC\_L1\_C2\_X\_N\_L**

**Figure 5.38: Frequency response function, phase and coherence (Cat 7): ACC MESA TRANS;  
ACC\_L1\_C2\_Y\_N\_T**

**Figure 5.39: Frequency response function, phase and coherence (Cat 7): ACC MESA LONG;  
ACC\_L1\_C2\_X\_N\_L**

To identify the dynamic characteristics of the Rusticasa building, the frequency response functions (FRF's) were computed with LNEC SPA [20] taking into account single input, multi output relations (SIMO) obtained from the characterization signals CAT 1 and CAT 7. Figure 5.36 and Figure 5.37 show an example of the frequency response function, phase and coherence in the transverse and longitudinal directions calculated for the channel ACC\_RL\_B2\_X\_I\_T and for the dynamic identification CAT 1. In Figure 5.38 and Figure 5.39 are shown the same but for the dynamic identification CAT 7.

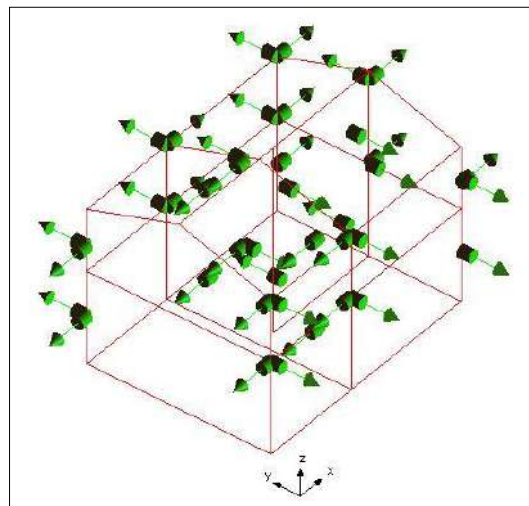
**Figure 5.41: Positions of the accelerometers in the house modelled in ARTEMIS**

On completion of the analysis, it was found that since the log house corners are formed by intersections of cross logs, it is difficult to obtain purely longitudinal or translational modes. The movement of the logs of one of the walls influences the movement of the orthogonal walls. However, based on the magnitude of movement, it was possible to characterize the mode shape. If the displacement of the walls in the X-direction was far greater than the displacement in the Y-direction, the mode was classified as longitudinal and similarly if the displacement of the walls in the Y-direction was much higher than in the X-direction, the mode was classified as a transverse.

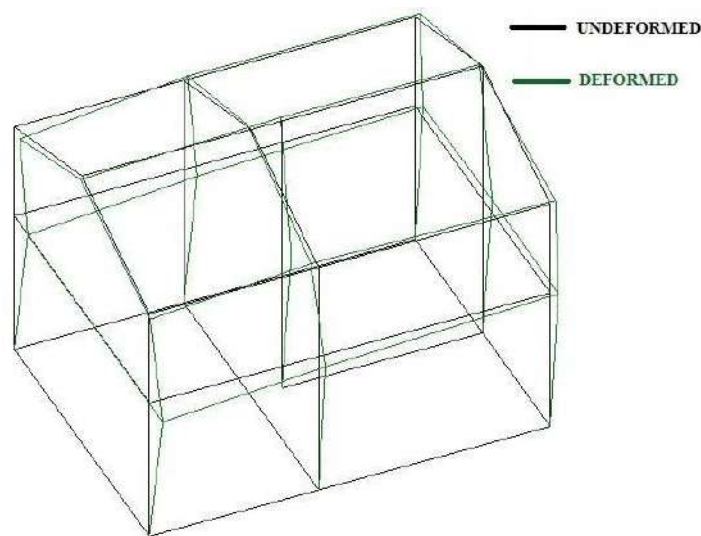
**Figure 5.49: The outlines of the deformed and undeformed structure of the log-house during the fourth mode**

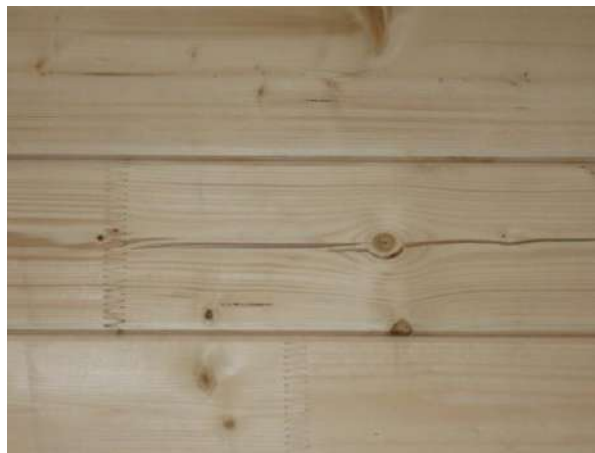
- Fracture along the length of the log due to out-of-plane flexure

**Figure 5.50: Crack seen along the grain of the log**

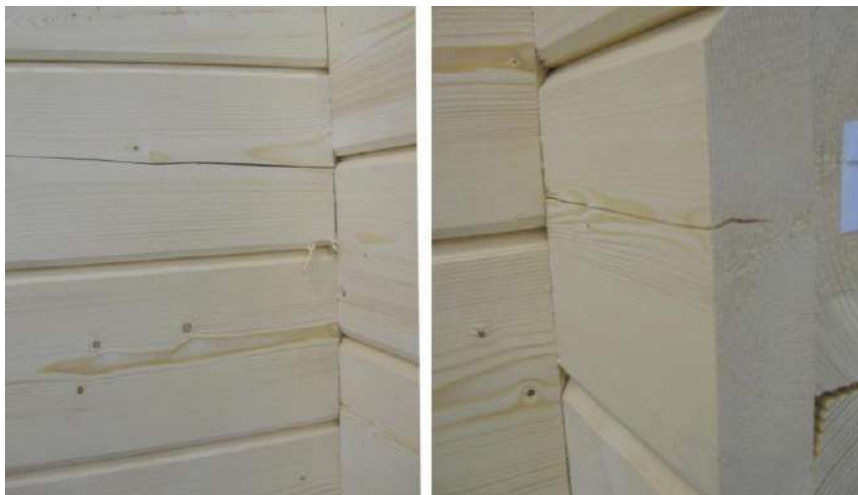
- Fracture along the grain at connections between orthogonal walls due to shear

**Figure 5.51: Cracks seen in logs at cross wall intersections**

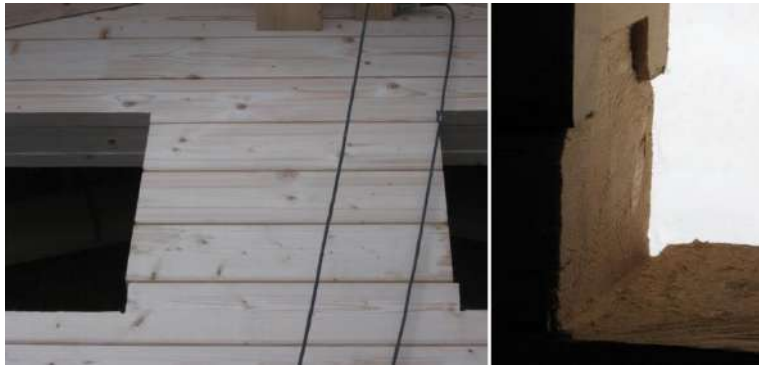
- Sliding of logs due to shear

**Figure 5.52: Sliding of logs near the window openings in the NW part of the house**

There were no signs of visible damage in the structure after the tests of 0.07g PGA were carried out. The only damage that was noticed after Test 7 (0.28g) was the sliding of the logs in the North Western Corner of the house, located near the window in wall P3. Once all the seismic tests were carried out, the following damages were observed:

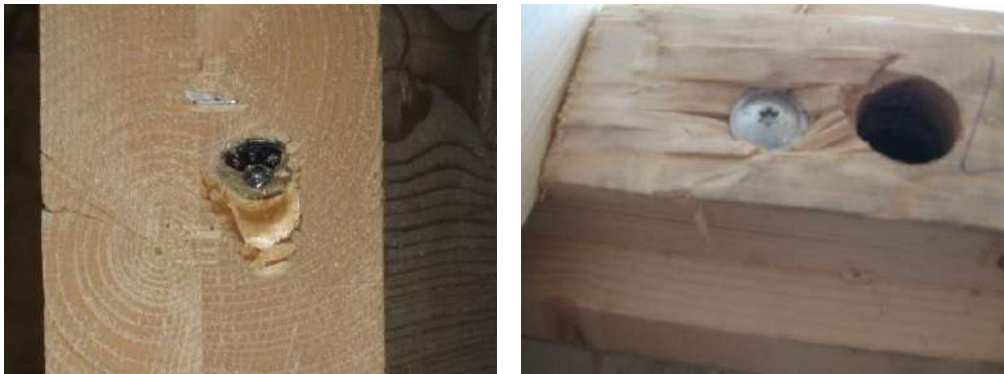
- Damage in the vicinity of the screws

**Figure 5.53: Chipping of wood around screws**

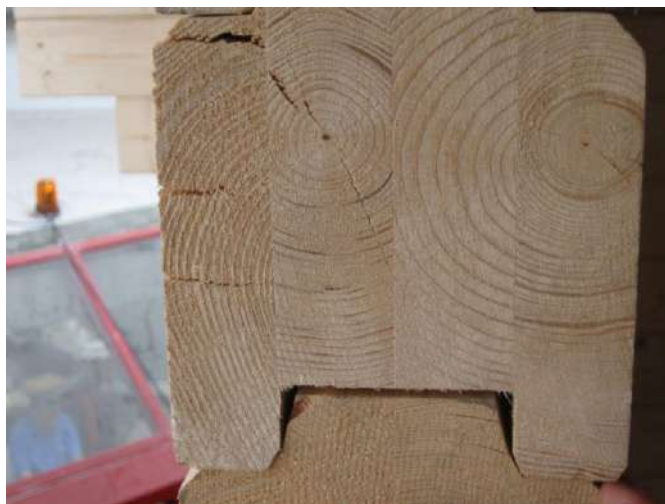
- Internal cracks in the log section

**Figure 5.54: Cracks visible in the cross section of the log**

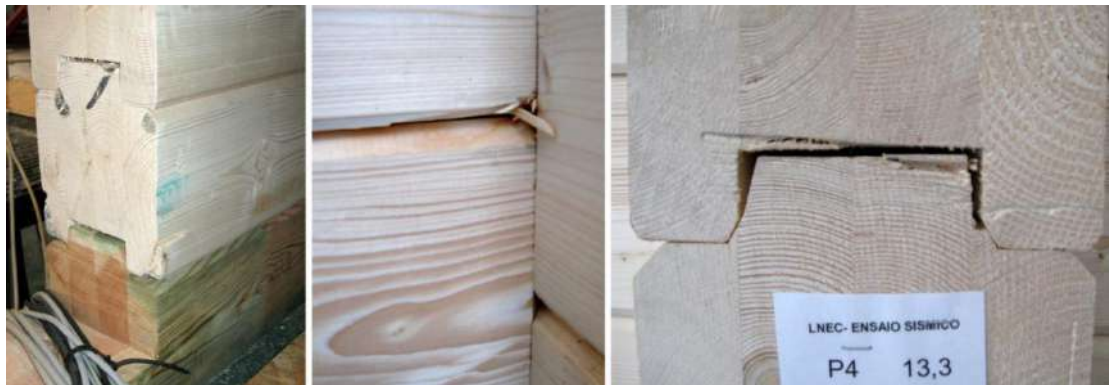
- Fracture at the top and bottom notches of the logs

**Figure 5.55: Damage to the top and bottom profiles of the log**

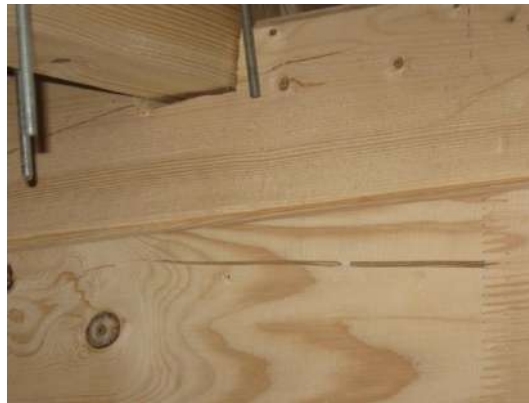
- Fracture at the intersection between floor beams and the wall

**Figure 5.56: Cracks seen near the intersection of the floor beams with the log wall**
